HYDROLOGY OF THE CENTRAL MANITOBA MINE TAILINGS

Michael W. Gupton, University of Manitoba, Winnipeg, Manitoba
Barbara L. Sherriff, University of Manitoba, Winnipeg, Manitoba
Caius Priscu, AMEC Earth and Environmental, Winnipeg, Manitoba
Jamie F. VanGulck, University of Manitoba, Winnipeg, Manitoba

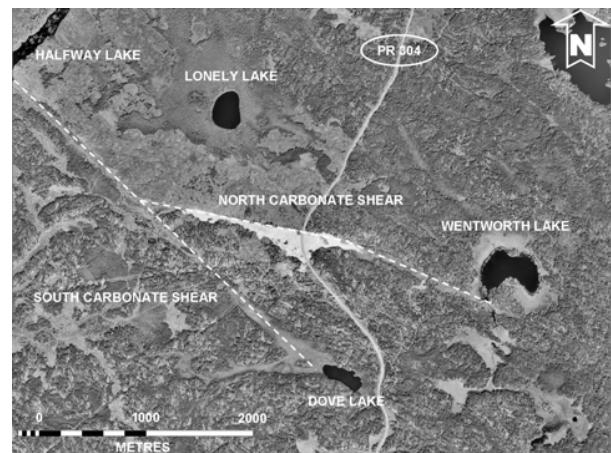
Figure 1. Orthophoto showing the surrounding lakes and their interconnectivity by the North and South carbonate shear zones.

site until after the tailings were deposited. The tailings were discharged as a slurry on top of a peat deposit within a granitic closed-catchment, bounded on the north side by a North Carbonate Shear zone (Figure 1).

An aerial orthophotograph of the surrounding area, as shown in Figure 1, suggests that the tailings may be hydraulically connected on a regional scale along the South Carbonate Shear with Halfway Lake, 1.8 km to the west, and Dove Lake, 1.2 km south, and along the North Carbonate Shear, Wentworth Lake, 1.0 km to the east. Lonely Lake is approximately 0.8 km north of the site and does not have a readily identifiable geologic structure connecting it to the site.

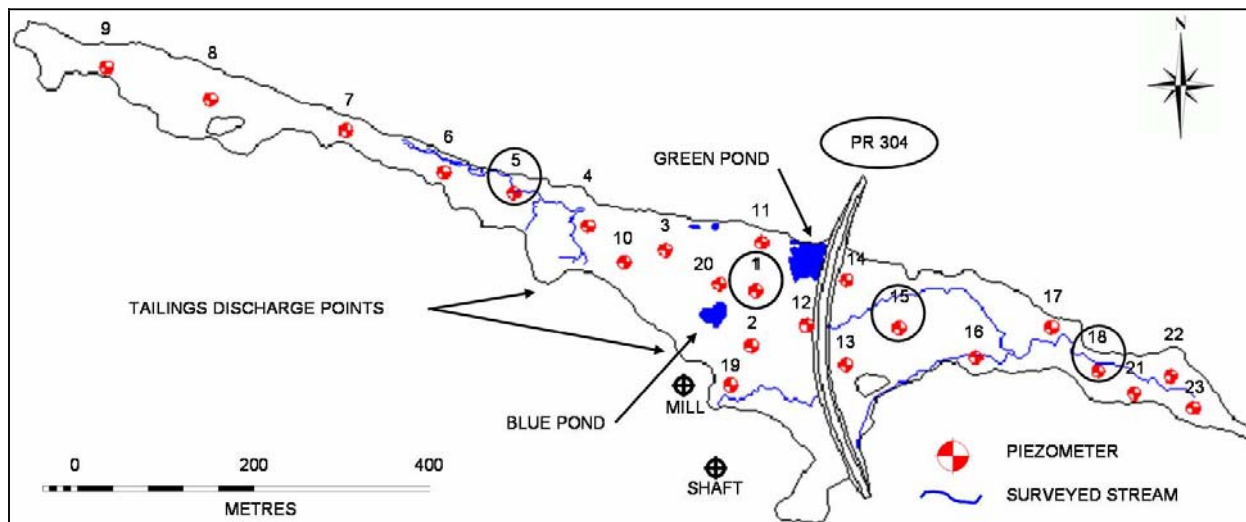
Figure 4. Plan view of the Central Manitoba tailings site showing piezometer and Shelby tube sampling locations (circled).

Groundwater fluctuations and the depth to the oxidized and non-oxidized boundary in the tailings were measured using twenty-three shallow piezometers installed across the site, ranging in depth from 0.4 to 2.3 metres. Figure 4 shows the piezometer locations.

Shelby tube samples of undisturbed oxidized tailings were taken adjacent to piezometers # 5, # 1, # 15, # 18, and, undisturbed non-oxidized tailings adjacent to piezometers # 5 and # 1 (Figure 4). Tubes were pushed in by hand to refusal, dug out, sealed, stored, and transported in an upright position to minimize sample disturbance. In addition, grab samples were taken of oxidized and non-oxidized tailings at different depths at each tube sample site for laboratory analysis. All piezometers and sample locations were assigned a Universal Transverse Mercator (UTM) planar projection coordinate address established by the GPS control network.

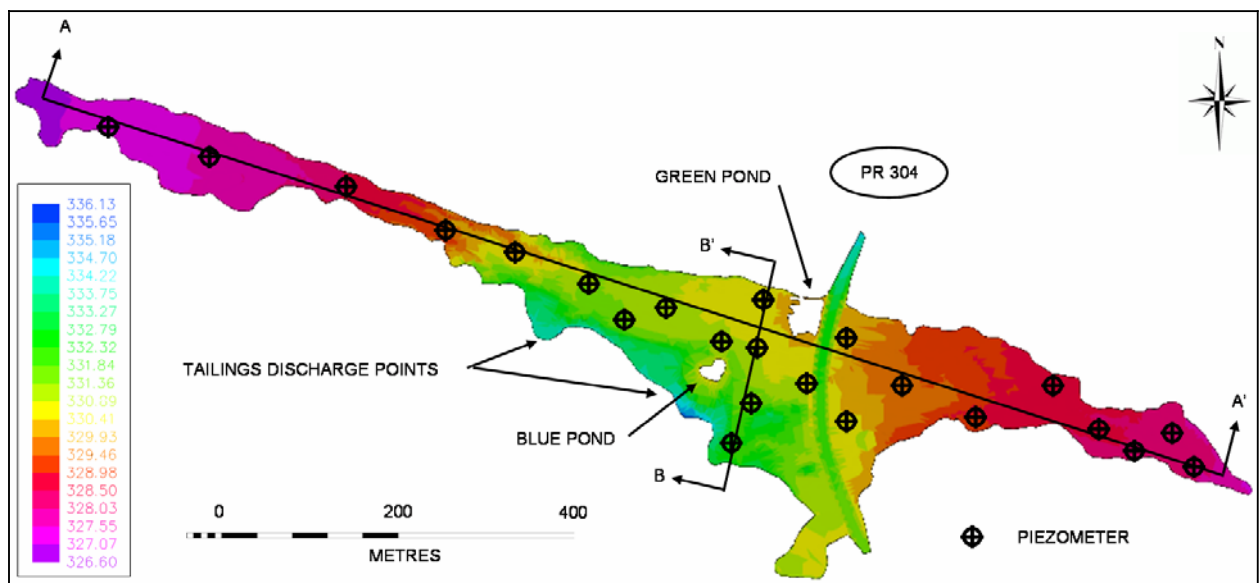
Groundwater level rise was measured in the 23 piezometers, one day after installation in June 2003, then again in August 2003, October 2003, and May 2004. Results are plotted along two cross sectional profiles, A-A' and B-B' shown in Figure 8. Cross section A-A' traverses the site longitudinally while cross section B-B' bisects the site along its widest transect closest to the mill.

Figure 8. Digital terrain model showing elevation change, piezometers locations, and cross sections A-A' and B-B'.

In August 2003, tailings had pushed up into the piezometer pipe about 0.023 - 0.850 m in 17 of the 23 piezometers. In May 2004, tailings had completely filled piezometers # 2, # 5, and # 6. This observation indicates that there is an upward component of groundwater flow in the tailings, which created a hydraulic gradient exceeding a critical value for piping to occur.
