CHARACTERIZATION AND REMEDIATION OF A CHLORIDE-IMPACTED AQUIFER IN NORTHWESTERN ALBERTA

Laurra P. Olmsted, Matrix Solutions Inc., Canada
Robert Boyce, Devon Canada Corporation, Canada

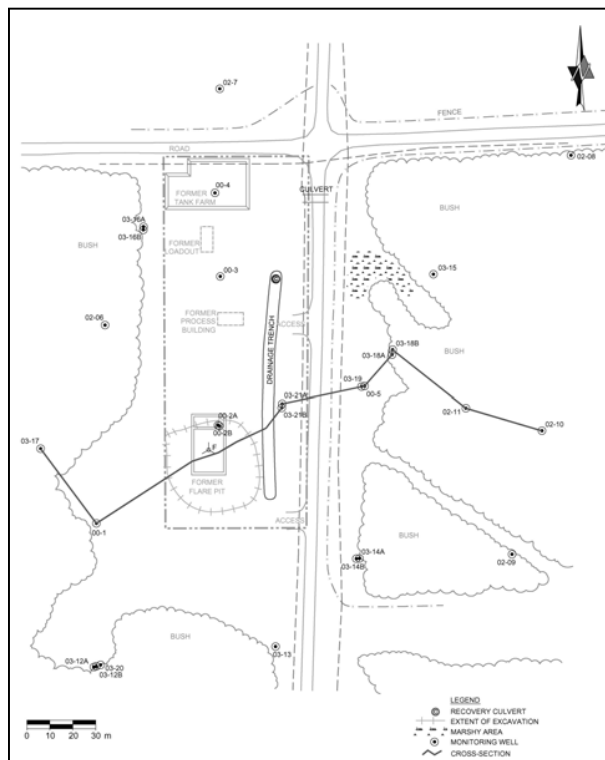
Figure 2: Site Plan

The site was constructed in the late 1950s and was operated for 25 years as an oil battery (where oil was extracted from the ground and primary separation of produced water and gas from the oil occurred). As shown in Figure 2, the site measures approximately 200m x 100m. The site is split by a north-south grid road and is bordered to the north by an east-west grid road. The oil and produced water were stored in a tank farm at the north end of the site. Waste fluids were typically disposed of in unlined earthen pits. When the site was reclaimed the flare pit was obliterated, equipment was removed from the site and the site was covered over by topsoil.

A tile drainage system was installed (by others) in 1996 to capture groundwater in the central part of the site. In 2000 Matrix modified the tile drainage system and identified the need for further remediation.
