Catastrophic piping failure of Saskatchewan Provincial Highway No. 16: A geohazard case study

P. Jorge Antunes MDH Engineered Solutions Corp, Regina, SK, Canada Moir D. Haug Department of Civil and Geological Engineering, University of Saskatchewan, Saskatoon, SK, Canada D. Chad LePoudre MDH Engineered Solutions Corp, Saskatoon, SK, Canada Brent L. Marjerison Saskatchewan Ministry of Highways and Infrastructure, Saskatoon, SK, Canada

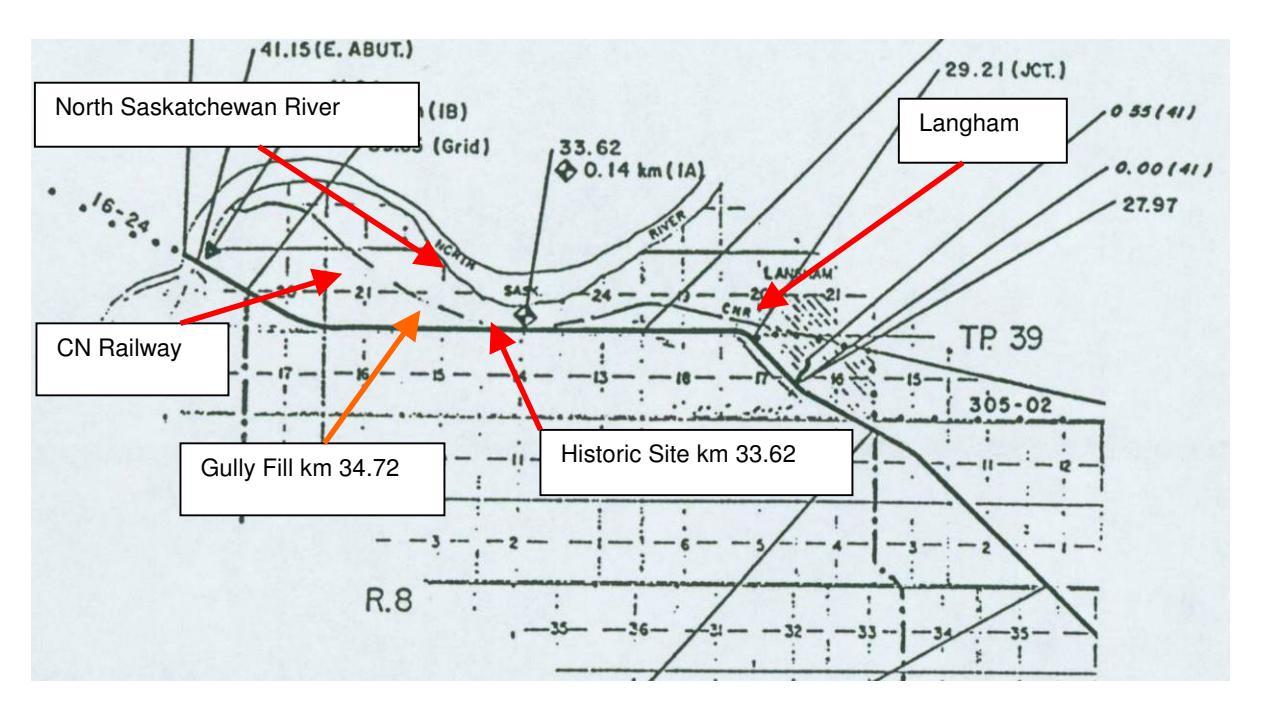
Figure 1: CS Map of Highway 16 west of Langham

In addition, numerous concerns have been raised about the overall North Saskatchewan River valley wall stability in this area as it relates to both the highway embankment as well as the CN Railway embankment. The valley wall instability is triggered by erosion of the North Saskatchewan River along a curved portion of the river immediately north of this site. The weak clay shale foundations and increased water table present at this site also contribute to the instability of the valley wall.

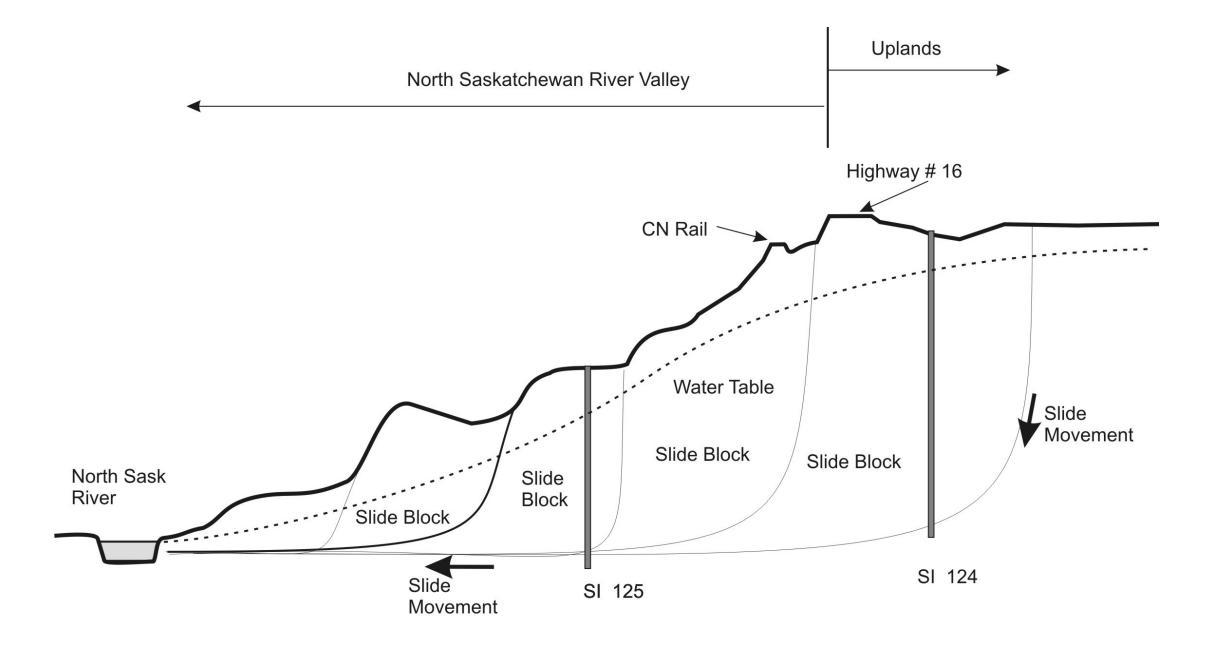
Figure 9: Conceptual slope model.

The highway in this location is also on an active landslide. A slope inclinometer (SI 124) to the east near the site of the overtopping showed movement. Another slope inclinometer (SI 125) down slope of the gully has shown considerable movement and at different depths. This SI is now inoperable. The readings from these slope inclinometers are shown in Figure 8. Two slope inclinometers installed in the gully embankment have both sheared off near the base of the embankment. Figure 9 contains a conceptual model of slope movement along the valley slope. The landslides slowly work their way up the slope (retrogress) when activated. The present westbound lanes appear to be just inside the last slide block, with only 5 mm of horizontal movement in the past 7 years. In contrast, SI 125 down slope has had over 50 mm of movement the past 6 years with multiple slip surfaces (at least 3 evident at SI 125 location). GeoEdmonton'08/GéoEdmonton2008
