## Overcoming Screen Collapse in a Test Well

Kent Wiezel, M.A.Sc., P.Eng.

*Stantec Consulting Limited, Fredericton, New Brunswick, Canada*

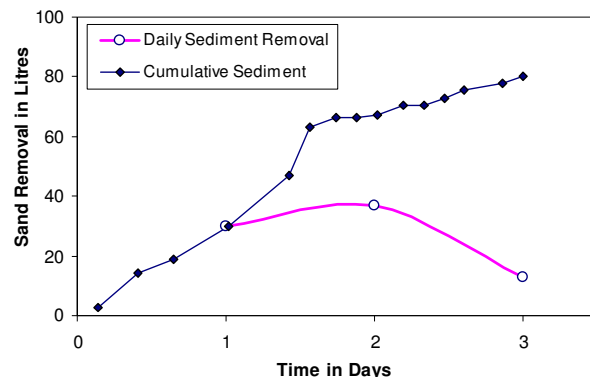
Development was continued using surge blocks for an additional 33 hours over 3 days with visible success in sand removal and rapid water recovery, becoming less productive as sediment removal diminished and water cleared more quickly after surge cycles (Figure 6). Hydraulic step tests conducted at three intervals during cable tool surging – 5 hours, 24 hours and 33 hours – suggested steady improvement of the well's performance, as discussed in Section 5.

Figure 6. Daily and cumulative sand removal from the test well during surging. Cable tool development continued until diminishing returns were noted.

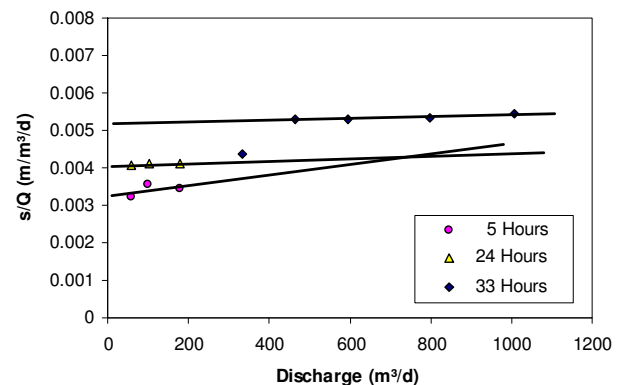
Hydraulic data from the three step tests provided the clearest indication of the test well's performance after the screen repair was complete. Linear fit plots for data at each of the three hydraulic step tests were used to assess the test well's performance and are presented in Figure 7. The plots show increasing specific capacity with development time, as indicated by the decreasing slope of each fit line (particularly between the early test at 5 hours and the two later tests), which should be expected in a "normally" behaving pumping well.

Figure 7. Linear fit plots for specific capacity at each hydraulic step test.

Table 2 shows well performance indicators from the hydraulic step testing. Walton's classification, which gives an indication of how a well is performing, showed that the test well improved from "severely clogged" to "properly designed" once development was complete. The calculated well efficiency at an equivalent pumping rate for each test increased from 71 to 95 percent during development.
