## Launched Soil Nail Slope Stabilization, Moosonee, Northern Ontario

Cameran Mirza, P. Eng.

### ABSTRACT

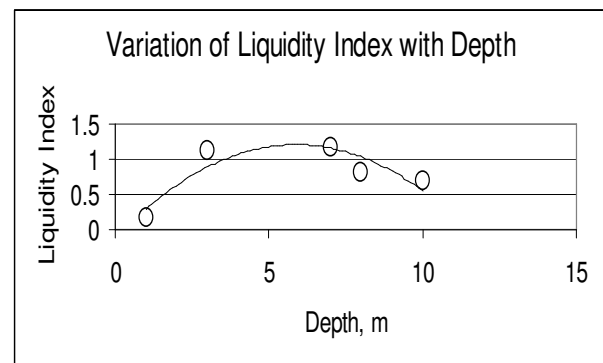
Figure 4 shows the liquidity index of the soil was greater than unity at depths of 4-6 m below the level of Revillon Road. The weakest part of the soil profile was thus thought to be located at a depth of 5-6 m below the level of Revillon Road.

Figure 4. Average liquidity index.

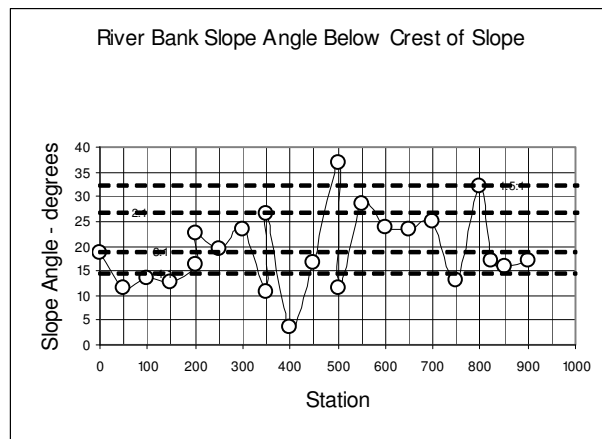
In November 2007, cross-section surveys were taken at 50 m intervals. The results are summarized in Figure 5.

Figure 5. Cross-section data.

From the results of Table 1 and the data of Figure 5, it became obvious that re-grading the river bank slopes to 4:1 or flatter to assure stability, especially during spring thaw rapid drawdown, was impractical due to encroachment into the river and the attendant environmental and navigational constraints. It was therefore decided to improve slope stability with launched soil nails with only some slight slope re-grading and biotechnical slope protection treatment, augmented with

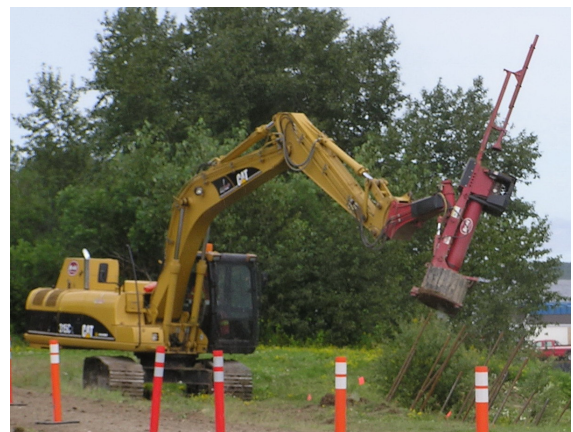
Figure 6. Hy-Speed soil nail launcher (red assembly attached to the backhoe stick).

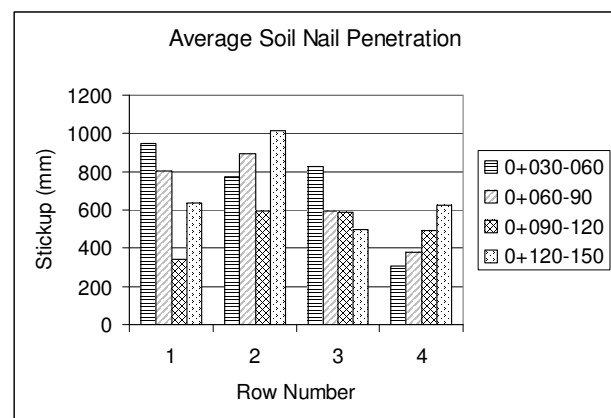
A statistical summary of the soil nails launched between Station 0+030 and 0+150 is shown in Figure 9. It will be seen that the fourth row of nails furthest down the slope generally penetrated about 200-300 mm deeper than the nails in the rows above, confirming the initial geotechnical assessment that the soil is softer at depths below 3-4 m (as indicated by the liquidity index, Figure 4).

Figure 9. Variability in soil nail penetration (by Stations).

The variability in soil nail penetration can be attributed to factors such as launch air pressure fluctuations and the random presence of roots and stones in the upper 2 m of the stratigraphy. The 6 m long soil nails penetrated, on average, a depth of 5.5 m below ground surface. Nail penetration varied almost linearly with launch air pressure (Figure 10).

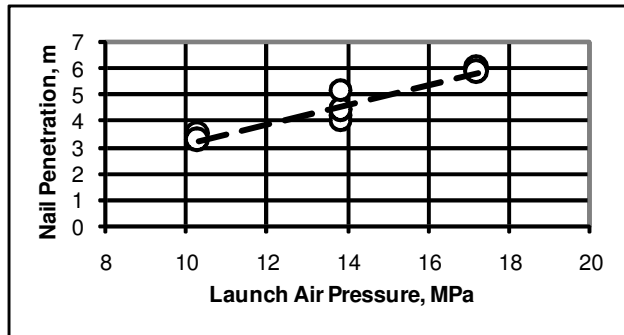
Figure 10. Average nail penetration vs. compressed air pressure.
