# Mechanisms and kinematics of three translational slides along the North Saskatchewan River Valley, Edmonton

K. W. Soe Moe

## ABSTRACT

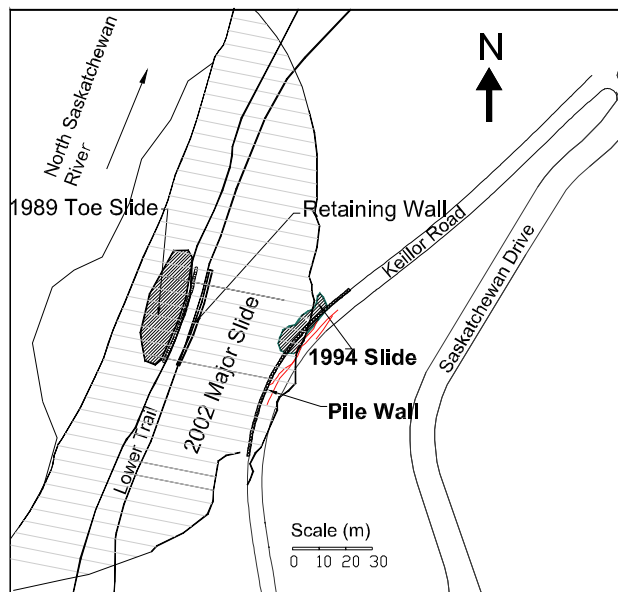
Figure 2 Map of slide area and site investigation plan

The Keillor Road Landslide started as a minor toe failure in 1989 causing some damage to a recreation trail at the toe of the slope (Barlow 1989). Fill had previously been placed to remediate a drop at the edge of the trail. After failure, a concrete retaining wall was constructed at the downslope edge of the trail to locally protect the trail from the effects of further instability (Figure 2).

In 1994, the movement progressed upslope causing some damage to Keillor Road, located about 40 m above the toe level (Bergman and Ruban 1995). The area, located on the outside of a horizontal curve near the top of Keillor Road, had been repaired periodically by the City of Edmonton. In 1997, an 8 to 15 m deep cast-in-place tangent pile retaining wall was constructed to protect the roadway.

The wall performed satisfactorily until August 2001 when a crack was observed across the roadway and the concrete wall. With time, the crack developed into a vertical scarp and a major failure occurred in the fall of 2002. The scarp was 50 m wide at the crown but widened to nearly 200 m at the river level. When the failure occurred, the head of the displaced material moved downward forming a graben. The main body of the slide translated along a horizontal plane in the bedrock.

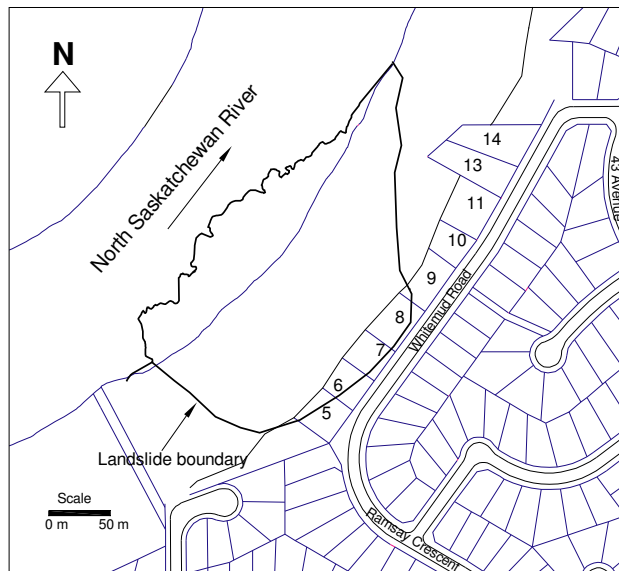
Figure 7 Location of Whitemud Road slide

On the morning of October 23, 1999, a large landslide occurred along a 270 m section of the North Saskatchewan River Valley in Edmonton (Barlow and Froese 2000). The failure affected seven residential lots on the west side of Whitemud Road between the intersection of Ramsay Road and 43<sup>rd</sup> Avenue (Figure 7). The upper two-thirds of the valley slope slid along a rupture surface located in the bedrock. As the failure progressed, the soil and rock above the failure plane cascaded over the bedrock and slid into the river. The total volume of soil and bedrock involved in the landslide was in the order of 250,000 m<sup>3</sup>. After the initial failure, 50,000 m<sup>3</sup> of this material was displaced into the river channel at the toe of the slope. As the main body translated along the surface of rupture, subsidence occurred at the head of the displaced material, resulting in a vertical drop of up to 18 m.

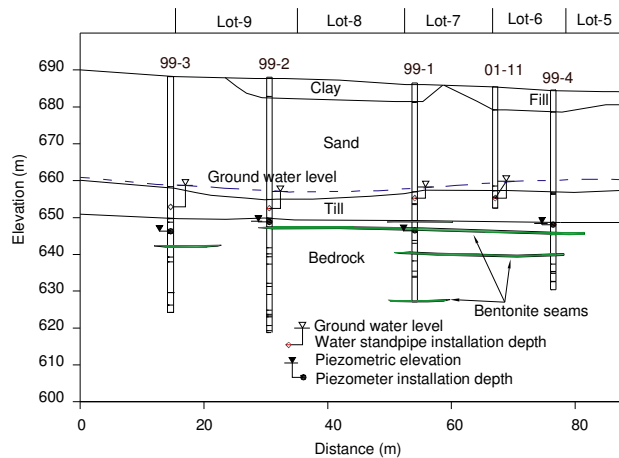
Figure 9 Cross-section along Whitemud Road

Post failure borings (Barlow 2005; Barlow and Froese 2000) revealed that the bedrock comprises interbedded layers of mudstone, clay shale and sandstone with thin bentonite layers (Figures 9).

The bedrock is Upper Cretaceous in age and part of the Horseshoe Canyon Formation of the Edmonton Group (Bayrock and Hughes 1962). When exposed to weathering processes, the bedrock swells and softens, particularly in areas of seepage discharge. The sandstone varies from a low plastic sandy clay to a weakly cemented soft rock. The mudstone and clay shale are generally hard, massive, high plastic and without any distinct fissility. Three separate bentonite layers with a

varying thickness from 50 to 400 mm were identified from deep borings (Figure 9).
