Slope Stabilization at Mt. Alberta View SE, Calgary, Alberta

Luis A. Martinez, Dennis E. Becker Golder Associates Ltd., Calgary, Alberta, Canada Victor Cui City of Calgary, Calgary, Alberta, Canada

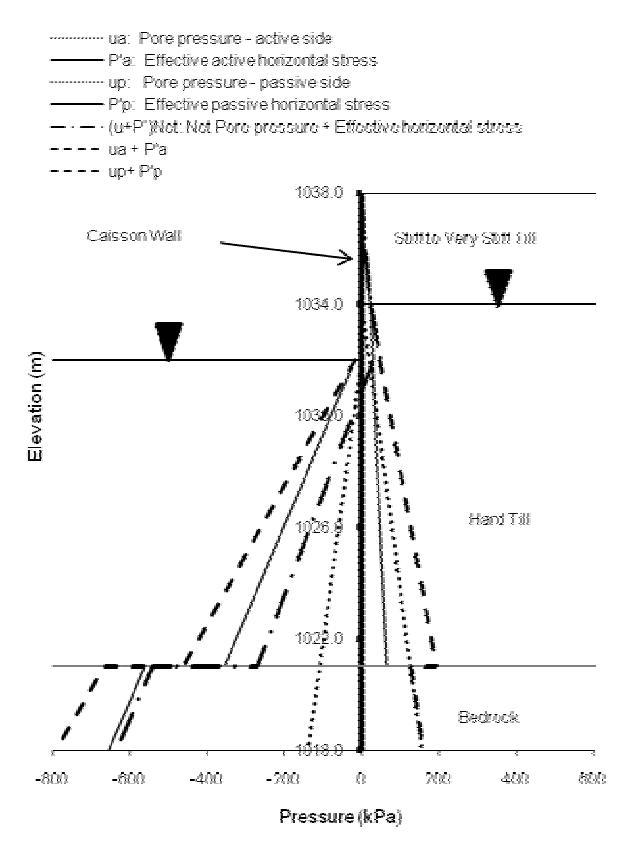
Figure 4. Design Lateral Pressure Diagram

The lateral earth pressure distribution used to assess the geotechnical stability of the caisson wall, estimate the anchor design load, design the steel reinforcing for the caisson wall and design the waler system is shown on Figure 4. The proposed earth pressure distribution takes into account a loss in ground in front of the wall of about 6 m to model potential ongoing slope retrogression.

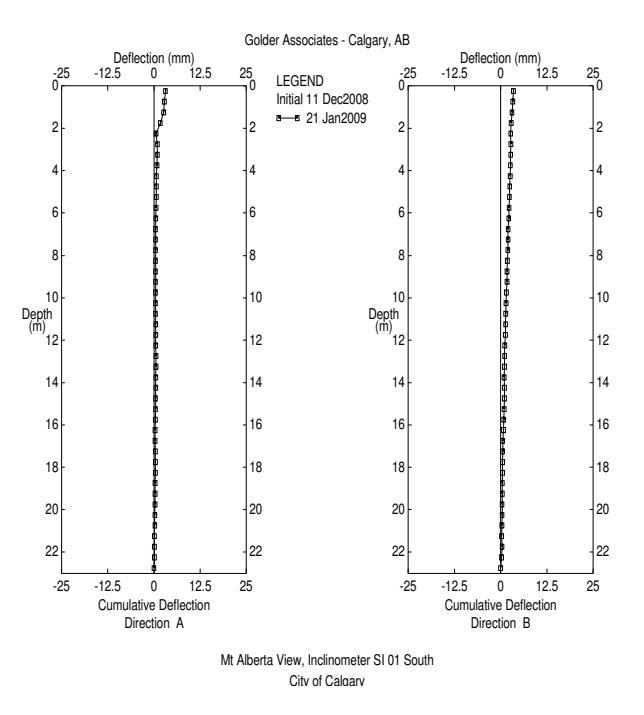
Figure 9. Slope Inclinometer Readings for the Inclinometer Casing within the South Portion of the Caisson Wall

One slope inclinometer casing was installed within the south and north portion of the caisson wall. Both inclinometer casings were installed 23 m below the top of the caisson wall. Base line readings were taken in December 2008. The first set of readings was taken after anchor stressing on January 2009. Slope inclinometer readings corresponding to the south inclinometer casing are shown in Figure 6. The A and B directions indicated are the directions perpendicular and parallel to the caisson wall, respectively. Deflections observed in Figure 9 are considered to be associated with compaction activities behind the caisson wall. Additional readings are planned to be taken after the heavy rainfall season (usually June and July) in 2009 (i.e. prior to preparation of this paper).
