# Development in hilly areas induced slope stability – case history

Kamal Bahrin Jaafar, Amir Hamzah Mustapha, Suhaimi Jamaluddin & Yunus Marjan  
*Public Works Department Malaysia, Kuala Lumpur, Wilayah Persekutuan, Malaysia*

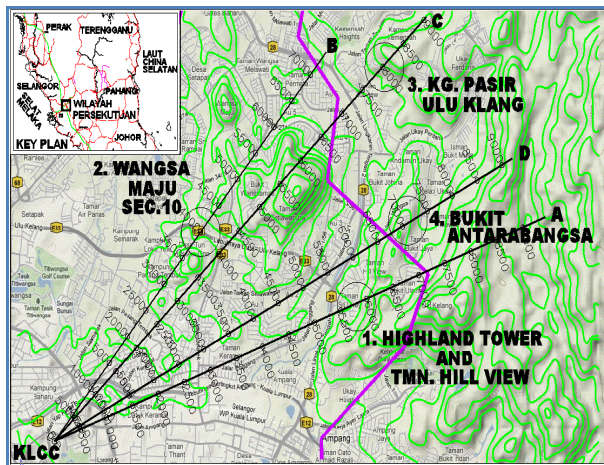
Figure 1: Location of landslide

Figure 1 shows the location of Kuala Lumpur City Centre (KLCC) as well as the location of landslides.

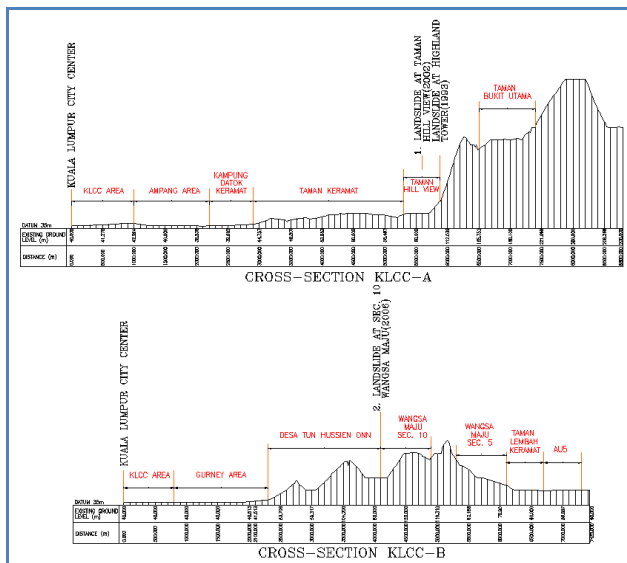
Based on cross-section KLCC-A to KLCC-D, all landslide locations are located at 100m above the sea level except for Highland Tower which was located at 70m from the sea level. Figure 2 and 3 show cross-section of the level of landslide location for five major landslides.

Figure 2. Cross-section KLCC - A refer to the collapse of Highland Tower and the landslide in Taman Hill View. In the essence of cross-section KLCC –B shows the location of landslide at Wangsa Maju.

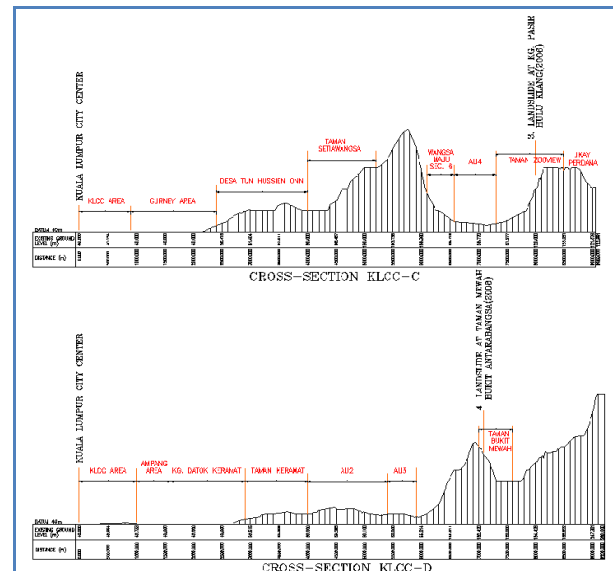
Figure 3. Cross-section KLCC - C refer to the landslide at Kg. Pasir Furthermore cross-section KLCC –D shows the location of landslide at Tmn. Bukit Mewah, Bkt. Antarabangsa.
