# Evaluating the Performance of a Frozen Core Dam Founded on Ice Rich Saline Marine Silts and Clays

Maritz Rykaart, Megan Millar, John Kurylo & Lowell Wade  
SRK Consulting (Canada) Inc., Vancouver, British Columbia, Canada

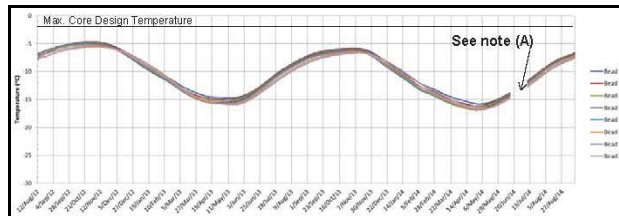
Figure 5. Time series data for ground temperature cable ND-HTS-130-33.5

In accordance with the design criteria, the North Dam core must at all times remain at a temperature below -2°C. The horizontal GTCs which are specifically focussed towards confirming this, clearly demonstrate that this design criteria is comfortably being met. This is illustrated

in Figures 5, 6 and 7 for the horizontal GTCs at chainage 0+130 m. Note (A) on these figures denotes a period when the data logger was not functioning supporting the conclusion that the data loss experienced does not detract from the ability to reach definitive conclusions about the dam performance. Not surprising, this data also shows greater annual variability in the core temperature where the core is closer to the surface.
