# Slope Stabilization at km 229 and km 701-703 of the Alaska Highway: Site Challenges and Lessons Learned

Jason Pellett, P.Eng./P.Geo. & Andrew Horwood, AScT Tetra Tech EBA, Vancouver, British Columbia, Canada

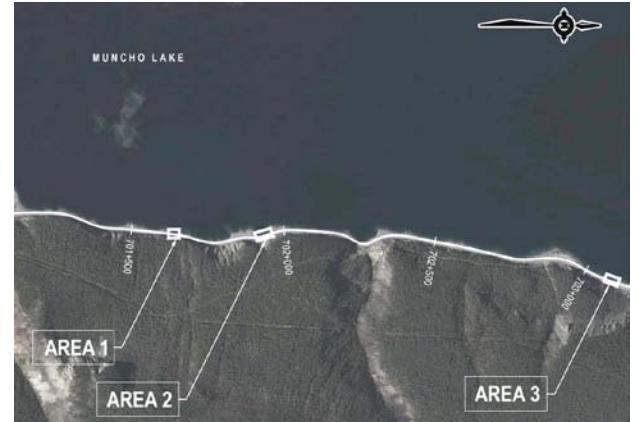
Figure 7. Site plan of km 701-703 vicinity showing location of Areas 1 to 3.

Three short (30 to 50 m long) sections of the highway between km 701 and 703 had developed a dangerously narrow shoulder over the last several years as a result of erosion and slumping of the shoulder material into Muncho Lake, and were continuing to deteriorate. Shoulder widths in these sections were generally between 0.5 and 1 m compared to 1.5 m or greater in adjacent areas. The stabilization and widening of these areas was identified as a priority by PWGSC out of concern for public safety and to reduce future highway maintenance requirements. Figure 7 shows the location of the three sites (herein referred to as Areas 1 to 3) along the shore of Muncho Lake.
