# The Inuvik Airport Runway – An evaluation of 50 years of performance

Ed Hoeve

Don Hayley

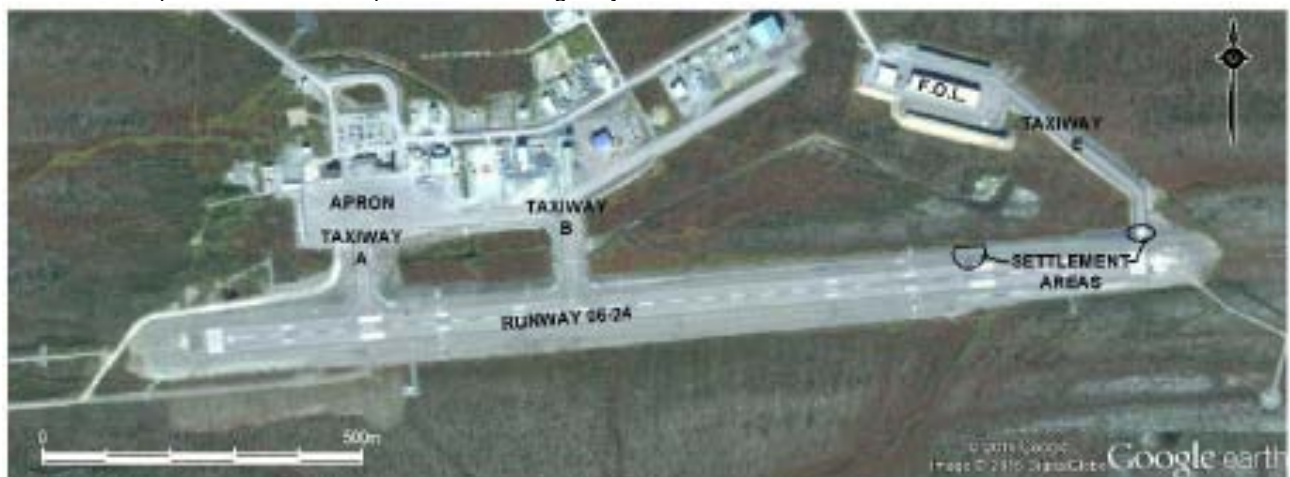
Figure 2. Airport Plan

The locations of these areas are shown in Figure 2. Both areas exhibited water at the toe of the embankment, indicating interrupted surface drainage; and longitudinal tension cracks in the gravel shoulders, indicating permafrost degradation. Both areas were given particular attention during a geophysical investigation at the airport (Tunnicliffe et al. 2011).
