# Temporary Slope Stabilization at the Airport Trail Tunnel Excavation, City of Calgary

Paul Xu, Ognian Gubev, Bronwen Kelley  
Laura Normore, Tara Rihn, Lee Nichols  
*Terracon Geotechnique Ltd., Calgary, Alberta, Canada*  
Kelly Illerbrun  
*PCL, Calgary, Alberta, Canada*

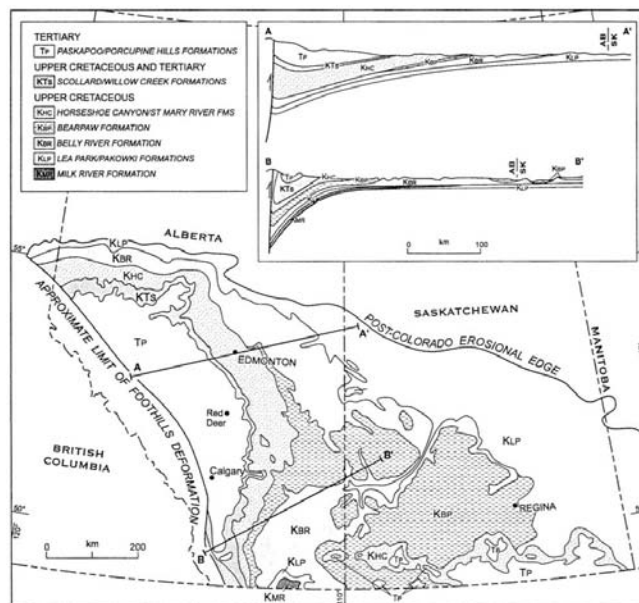
Figure 3: Upper Cretaceous - Tertiary Depositional Assemblages, Western Canada Sedimentary Basin

The bedrock of the Calgary urban area consists primarily of flat lying to gently dipping sandstone, siltstone, and claystone of the Paskapoo Formation (Figure 3). Sediments in the area of the ATT excavation are from the Lacombe Member of the Paskapoo Formation which contains variable beds of fluvial channel sand and muddy floodplain sediments laid down during the Paleocene Epoch. The unit has been characterized as having marked inhomogeneity both vertically and horizontally within the succession (Hamblin, 2004). The siltstone and claystone lithologies are weather susceptible consisting of
