Case Study of a Landslide on Highway 20 North of Craven, SK

Harpreet Panesar¹, Hung Vu², Laurie Stang², Jody Schafer¹, Hamid Soleymani¹

¹*Ministry of Highways and Infrastructure, Regina, Saskatchewan* ²*Golder Associates Ltd., Saskatoon, Saskatchewan, Canada*

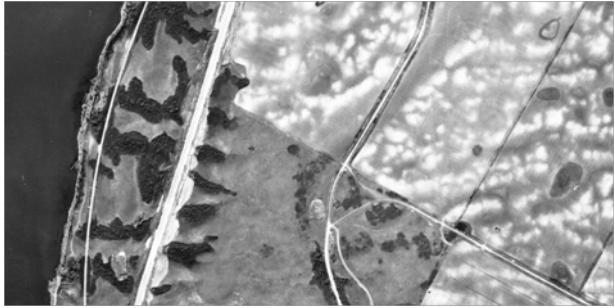
Figure 3. Aerial photograph of the site from 1969

Aerial photographs covering the site area from 1969 onwards were evaluated. Aerial photographs indicate that CS 20-01 was constructed before 1969, and that sections of the highway embankment were constructed over vegetated areas. The photographs indicate that the high embankment fill, at the location of both slides, traverses depression areas of thick natural vegetation.

The old failure scarp on the east ditch back slope shown in Figure 2 is also noted on aerial photographs dating back to 1969. Aerial photographs also reveal that the residential property at the crest of the back slope, approximately 75 m east of the north slide, was constructed sometime after 2001.

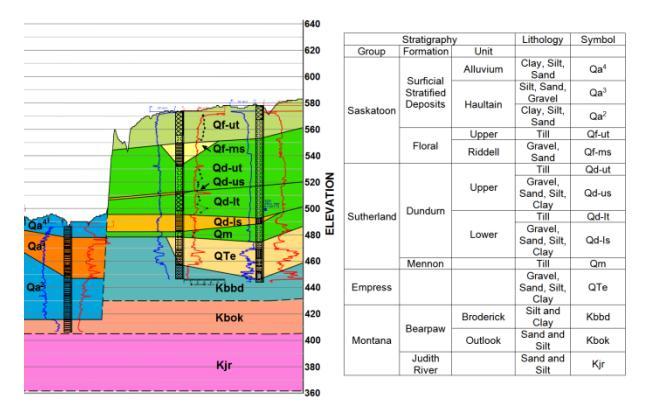
Figure 4. Regional geology of Qu'Appelle valey area (modified cross-section from Water Security Agency)

The Qu'Appelle Valley is a glacial meltwater spillway eroded through 48 m to 65 m of till into clay shale of the Bearpaw Formation. The total depth of erosion is about 109 m below the valley crest at elevation 559 m (thalweg at elevation 450 m). The Bearpaw Formation lies in conformable contact with the Judith River Formation which occurs at about elevation 410 m. (Figure 4)

The contact between the till and the clay shale would likely be represented by a gouge zone in the shale create by glacial shear. Gouge zones are typically in a remolded condition. The effective friction angle of gouge in clay shale of the Bearpaw Formation is most likely at residual state.

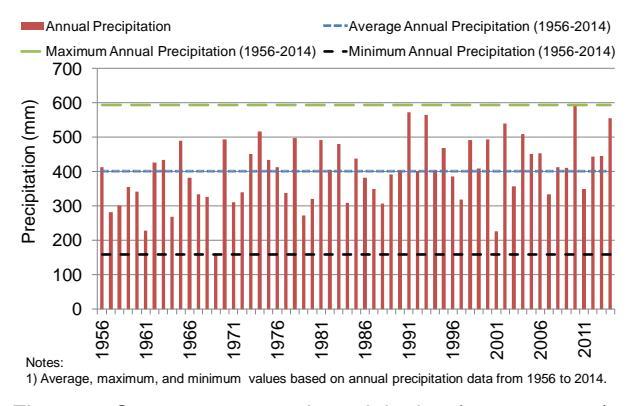
Figure 6. Cupar area annual precipitation (1956 to 2014)

The precipitation data reveals high annual precipitation for the majority of the past decade; recorded annual precipitation during the past decade was above the average value for 1956 to 2014 (401 mm/year), with the exception of 2007 and 2011 (Figure 6). The highest annual precipitation recorded between 1956 and 2014 occurred in 2010, when 595 mm of precipitation was measured; followed by a year of slightly below average annual precipitation in 2011 (349 mm). Annual precipitation measure in 2012 and 2013 was slightly

above average, while 2014 was the fourth wettest year on record (555 mm).

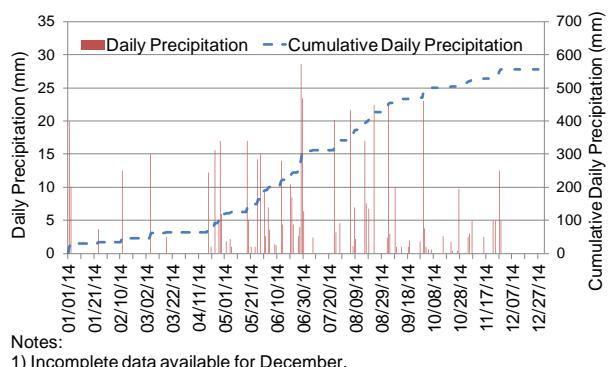
Figure 7. Cupar area daily and cumulative precipitation

Sustained daily precipitation between June 26 and 30, 2014 amounted to 65 mm, with 52 mm concentrated on June 28 and 29, 2014 (Figure 7). Total precipitation recorded for June 2014 was 122 mm.

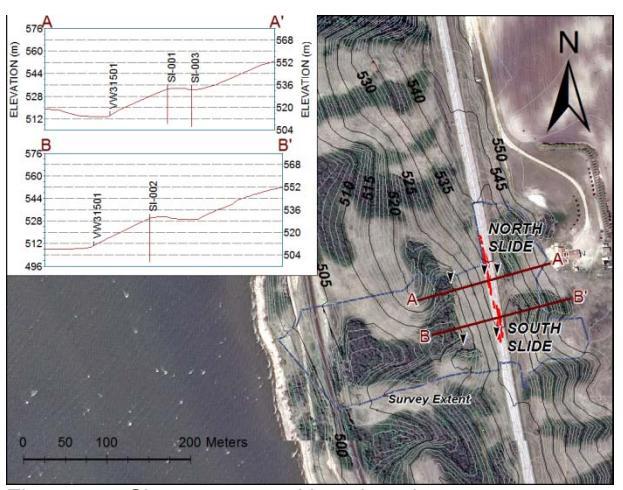
Figure 10. Site contour and location plan

The topographic survey was completed using GPS survey equipment. Horizontal datum was referenced to the NAD 83 Transverse Mercator coordinate system; surface feature elevations were referenced to geodetic datum CGVD28. Figure 10 shows the plan view of the survey area, contours and slope stability cross-sections. Digital Terrain Model (DTM) data was used to extend the contour plan beyond the limits of the topographic survey. Cross-sections A-A' and B-B' are also shown on Figure 10.

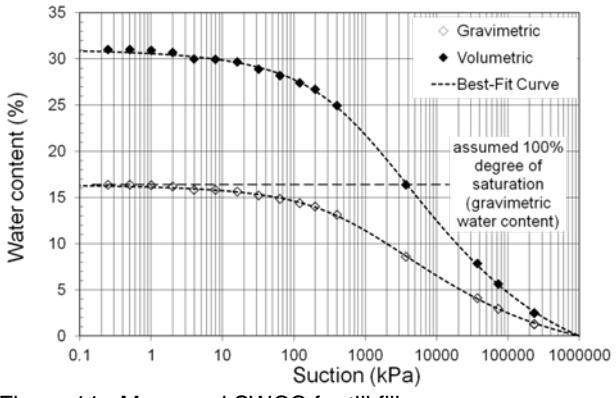
Figure 11. Measured SWCC for till fill

Figure 11 shows the measured SWCC's for the till fill sample from this site. The air-entry value (AEV) determined from the measured SWCC for this sample was approximately 200 kPa and there was no distinct residual value; however it appeared to be around 10,000 kPa.

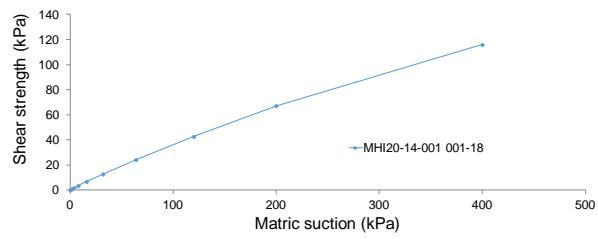
Figure 12. Estimated unsaturated shear strength envelope for till fill

In slope stability analysis the contribution to the shear strength by suction is simulated by the input of either φ^b or the "apparent cohesion" (i.e., the strength arising from suction). Based on the estimated unsaturated shear strength envelope shown in Figure 12 the angle φ^b for till is approximately 15 degrees.
