# Calgary Cancer Centre – Design and Construction Challenges for a Deep Excavation and Building Foundations within Lacustrine Clay

David A. Field, MSCE, P.Eng. & Mathew Stenhouse, B.Eng. E.I.T.  
*Thurber Engineering Ltd., Calgary, Alberta Canada*

The Calgary Cancer Centre, currently under construction within the Foothills Hospital Campus in Calgary, Alberta, presented challenges for design and construction of an effective shoring system and building foundations. The building has 13 stories above grade and extends 5 levels (18 m) below existing grades and occupies a tight footprint surrounded closely by major roadways and sensitive utilities. Weak and saturated lacustrine soils extend beneath the site to a depth of approximately 13 m, presenting concerns for maintaining adequate excavation support to allow for a deep excavation without damaging adjacent roadways or utilities servicing the hospital facility. This paper discusses the methods used to characterize the engineering properties of the site soils, the associated shoring and foundation design challenges and the selected designs.

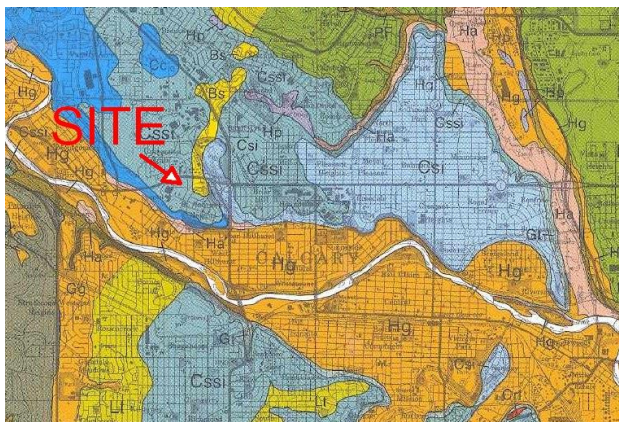
Figure 2. Site location within lacustrine sediments (blue)

The site's location is described in the Surficial Geology of the Calgary Urban Area (S. R. Moran 1986) as a region mantled with glacial lacustrine soils consisting of silt, clay, and very fine sand which can exceed 50 m in thickness (Figure 2.) These weak and typically saturated sediments contrast markedly with the more common glacial clay till, fluvial sand, and gravel soils of the Bow River valley and surrounding Calgary region. A review of historical aerial photos prior to development of the Foothills Medical Centre, indicated that a small pond or slough was present within the CCC building footprint, which likely contributed to the near surface weakness and high moisture contents noted within the site lacustrine soils (Figure 3).

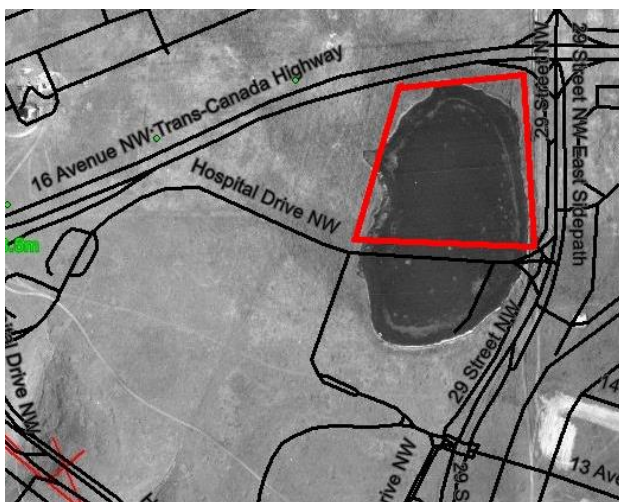
Figure 3. Pre-development aerial photo of site (1953)

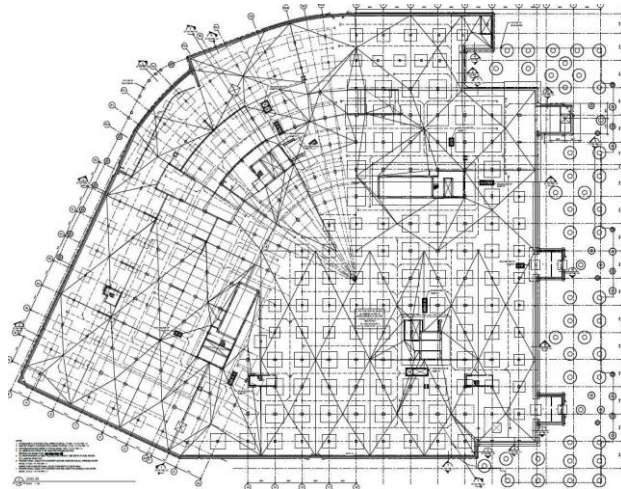
Figure 5. Plan view of varying foundation layout

The individual footing and pile foundation layout, applied loading and structural details were adjusted as required to achieve a relatively uniform foundation response. A plan view of the various foundations is shown on Figure 5, illustrating the wide variety in footing spacing and size.

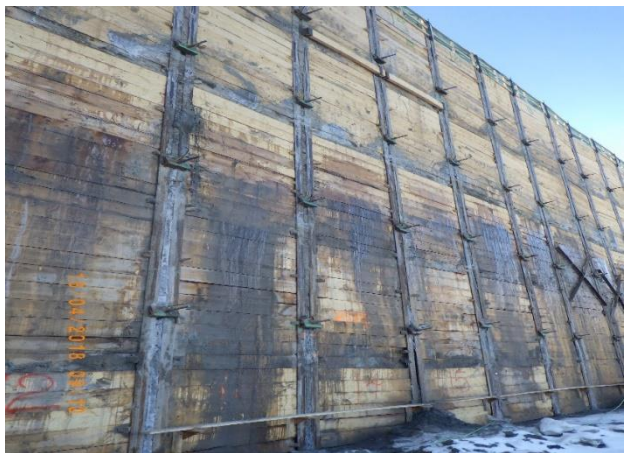
Figure 6. Completed temporary shoring system

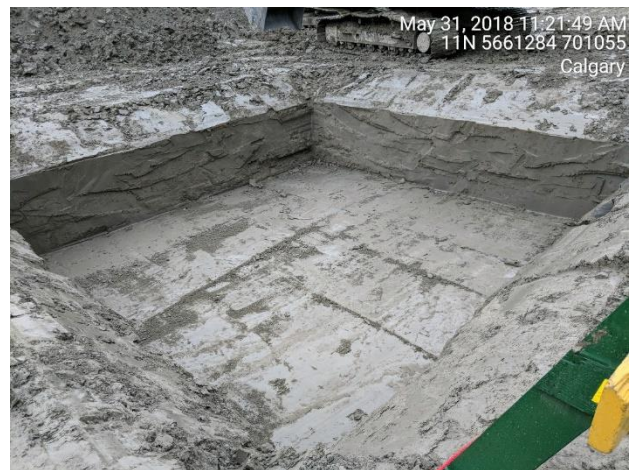
Figure 7. Typical foundation pad cut within till

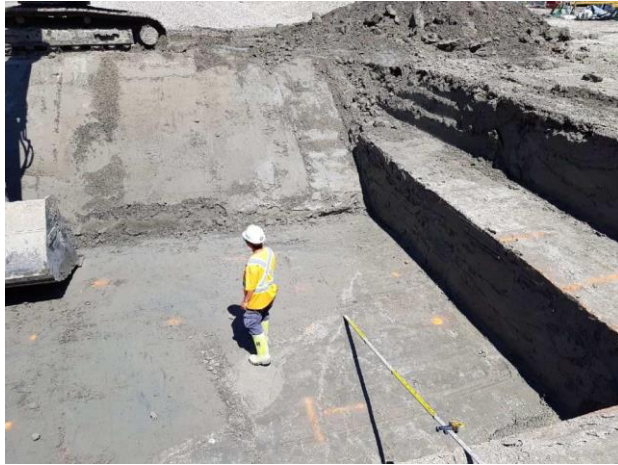
Figure 8. Foundation pad with sloped wall after removal of weak soil zone

In locations where the saturated cohesionless soils extended beyond a footing pad's perimeter and where space allowed, the weak side of the footing pad excavation was sloped up to the floor slab subgrade and wooden forms were utilized to cast the foundation pad (Fig 8). The use of over-excavation of cohesionless soil zones and partial footing pad forming allowed for foundation installation to proceed smoothly.

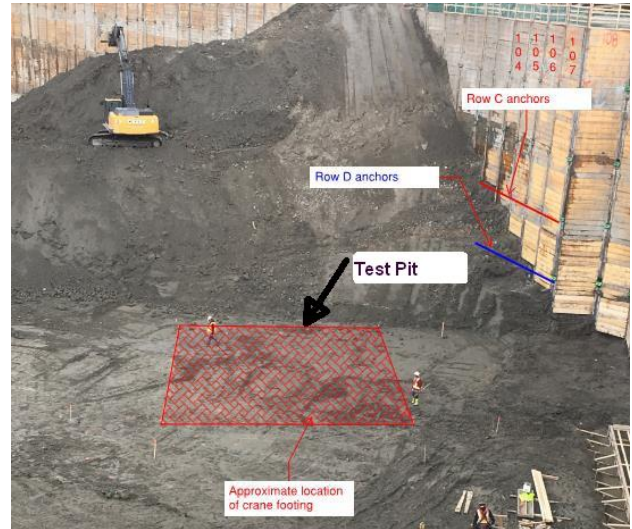
Figure 9. Tower Crane 1 footing test pit location

The footing excavation for Tower Crane 1 required a large excavation to a depth of 2.6 m below the surrounding grade. A test pit was excavated ahead of performing the full footing excavation for Tower Crane 1 due to concerns with exposing too much weak soil at once. The location of the test pit and the extent of excavation at that time are shown on Fig 9. The wall of the test pit cut cleanly and initially stood vertically. Groundwater was observed seeping in through the walls and base of the test pit which quickly led to loss of strength and sloughing (Fig 10). Further excavation and site observations indicated that the zone of weak cohesionless soil observed in the test pit extended beneath the remaining portion of the Tower Crane 1 base excavation and appeared to be continuous in the direction of the adjacent shoring wall.

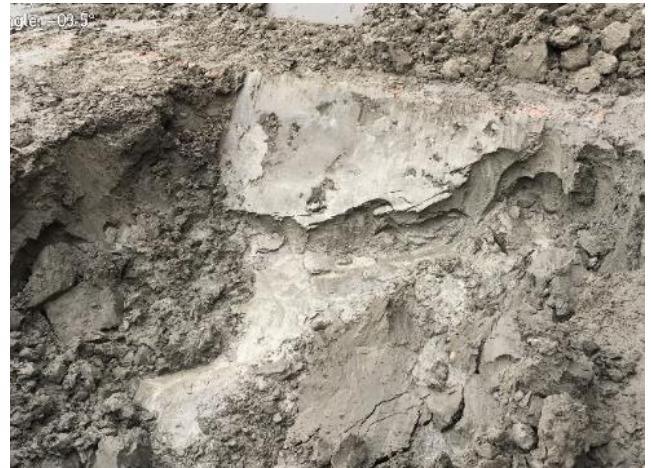
Figure 10. Sloughing soil in Tower Crane 1 test pit

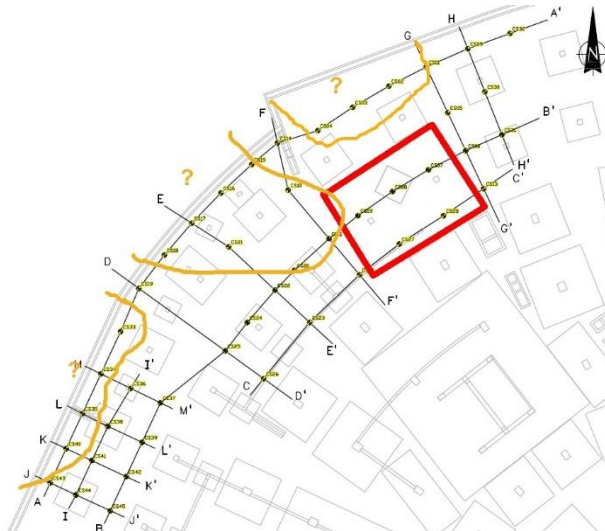
Figure 11. Excavation boreholes and cohesionless soil

The probable extent of the cohesionless soils raised concerns for the installation of the remaining footings and stability of the temporary shoring due to the depth of soil to be removed near the shoring wall toe. The remaining soil ramp was flattened to facilitate drilling a series of 46 shallow boreholes within the excavation to help refine the approximate lateral and vertical extent of the cohesionless soil zone ahead of further excavation. It became apparent from the boreholes that the cohesionless soil varied in lateral and vertical extent. The approximate plan view regions of thick layers of saturated cohesionless soil are shown on Figure 11.

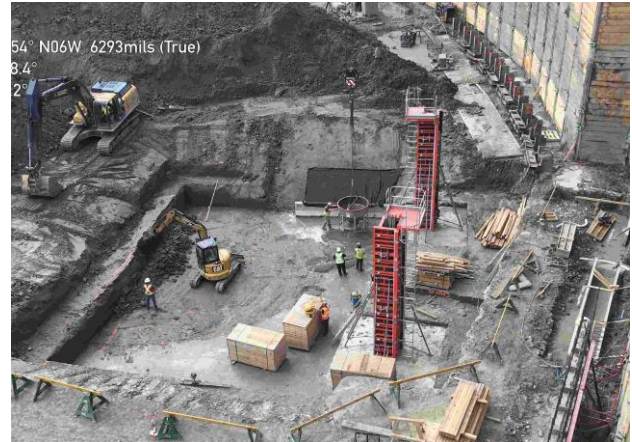
Figure 12 shows the footing excavation for Tower Crane 1 just as drain rock was to be placed behind the Jersey barriers. Evident in the photo is the secant pile wall along

the toe of the shoring wall and the mud slab installed within a portion of the base of the pad excavation. Only a portion of the pad side wall required stabilization using Jersey barriers and drain rock backfill. The weak cohesionless soil was in stark contrast to the surrounding competent till which can be seen cut vertically along the remainder of the pad.

Figure 12. Completion of Tower Crane 1 footing (facing west)
