# Construction of the A21 Dike at the Diavik Diamond Mine

Angela Küpper, Joan Roca & Greg Wenger  
BGC Engineering Inc., Canada  
Gord Stephenson  
Diavik Diamond Mines (2012) Inc., Canada

The Diavik Diamond Mine is located on East Island in Lac de Gras, Northwest Territories (Canada). The A21 Dike is the third water-retaining dike constructed within the lake to enable dewatering of the area enclosed by the dike and allow open pit mining of the A21 Kimberlite pipe. The A21 Dike is a zoned rockfill embankment with a seepage cut-off wall. The cut-off wall comprises a single-row grout curtain in bedrock, cutter soil mixing panels through the dike embankment and foundation soil, and jet grout columns through the foundation soil and soil/rock interface. Changes in design and construction methods from the previous A154 and A418 Dikes were introduced with the intent of reducing costs, optimizing the project and accommodating the site conditions and schedule constraints. Although these changes led to a project that was recognized to be less robust than the previous dikes, the A21 Dike was completed on time and under budget and is currently performing as intended. This paper describes the

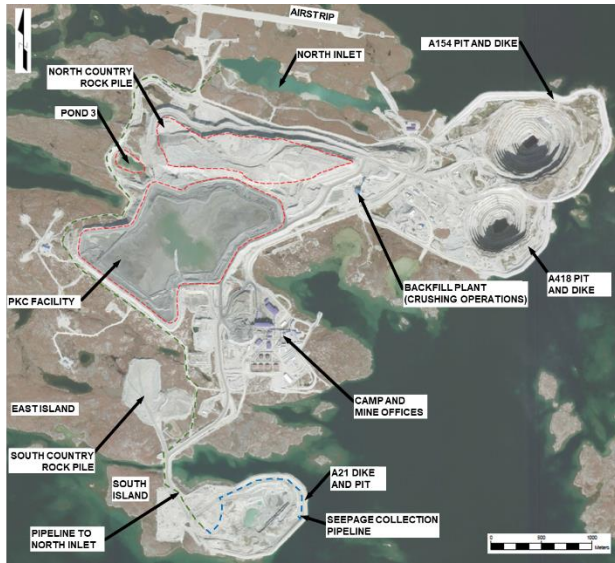
Figure 1. 2018 satellite image showing the Diavik Diamond Mine Site, and approximate locations of site infrastructure.

The mine site is located on an island where personnel are transported via airplane. Primary resupply of materials, equipment and fuel are transported from Yellowknife via a temporary ice road built and operated during the winter. Figure 1 shows the approximate location of key mine site

infrastructure. The A21 Dike and A21 Kimberlite pipe are located at the south end of the mine site.

The permanent seepage collection and drainage system controls the water level inside the downstream section of the dike by collecting water at select locations and pumping it to the North Inlet (see Figure 1). The system includes two Dike Pumping Stations (DPS), three pump wells, a main collector pipeline and its pumping system. The pump wells are located at select locations on the downstream shell of the dike to manage ponding water within the downstream shell of the dike. The two DPS are installed at the downstream dike toe to manage seepage through the dike and ponding water at localized depressions downstream of the dike toe. The insulated and heat traced collection pipeline is situated on the crest of the toe berm constructed along the dike toe after dewatering. The toe berm crest is approximately 5 m wide and its height ranges from 0.5 to 9.8 m above the prepared foundation.

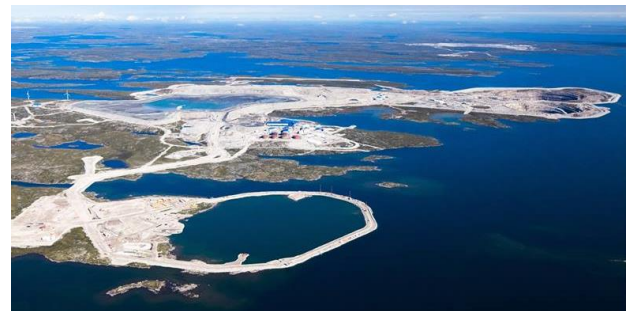
Figure 6. Aerial view of the A21 Dike (foreground) looking north during construction of the COW in 2017. On the right (background), A418 and A154 Dikes and open pits.

Figure 6 shows the A21 Dike configuration during the summer of 2017, before dewatering of the internal pond enclosed by the dike. The internal pond was dewatered using two pumping systems. The Phase A system consisted of large capacity submersible pumps discharging directly into Lac de Gras, as the water quality allowed. Phase B system included submersible pumps discharging into the North Inlet, where the water could be treated before discharge into Lac de Gras.
