GEOTECHNICAL STUDY ON SLOPE STABILITY IN VICINITY OF RIVER VALLEY

Lifang Jia, Soil-Eng Limited, Toronto, Ontario, Canada
Victor Chan, Soil-Eng Limited, Toronto, Ontario, Canada

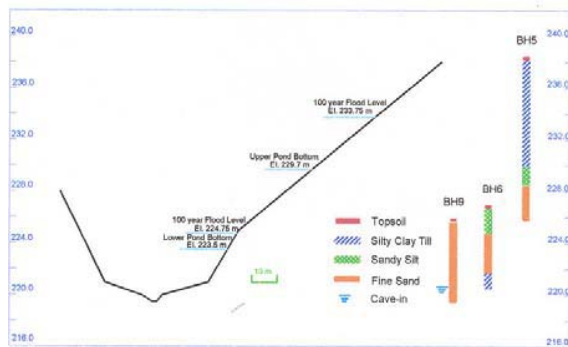
level of the pond is at El. 231.85 m and El. 224.00 m, respectively, for the sediment forebay at the upper facility and for the lower facility; the bottom of the pond of the upper and lower facilities is at Els. 229.70 m and 223.50 m, respectively. The 100 year flood levels are Els. 233.75 m and 224.75 m, respectively, for the upper and lower facilities. Figure 1 shows simplified stratigraphic cross-section.

Figure 1. Cross Section and Subsurface Profile

The field work was carried out by Soil-Eng Limited. Field work, consisting of advancing 9 boreholes to depths ranging from 6.6 to 12.7 m, was performed on September 29 and 30, 2003. Boreholes 5, 6 and 9 (Borehole Logs shown in Figure 1) will be used in slope analysis.

- Stratigraphy Structure: the investigation has disclosed that the bank is underlain by a stratum of firm to hard, generally hard silty clay till, overlying strata of dense sandy silt (Els. 228.5 to 230.0 m) and loose to very dense fine sand (El. 219.3 to 225.9 m) beneath sandy silt, in place, overlying the silty clay till deposit. This shows the upper pond will extend into the relatively pervious sandy silt stratum and the lower pond will extend into the pervious fine sand on which the creek meanders.
