LANDSLIDE STABILIZATION MEASURES FOR A BRIDGE CROSSING

Bradley S. Prince, M.Eng., P.Eng., AMEC Earth & Environmental, Edmonton, Canada

ABSTRACT

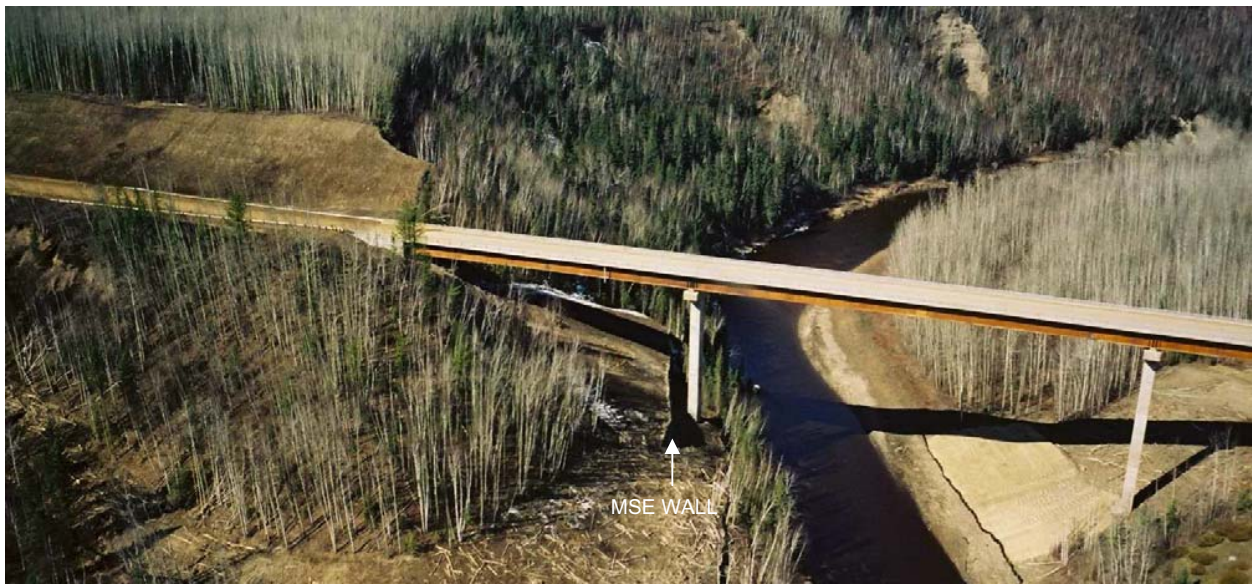
Figure 6. Photo of the Completed Bridge and Shear Key / MSE Wall Looking Southwest

Construction of the shear key/MSE wall was carried out primarily during the summer of 2003. Full-time geotechnical monitoring was carried out during construction, which included frequent reading of inclinometers installed upslope of the shear key. Although the panel size adopted by the design/builder was somewhat larger than visualized during design, the slope performed well with no significant instabilities triggered during construction. The bridge was opened to traffic in November 2003 and the shear key/MSE wall has performed well since that time. Photos of the completed bridge and shear key / MSE wall are shown in Figures 6 and 7.

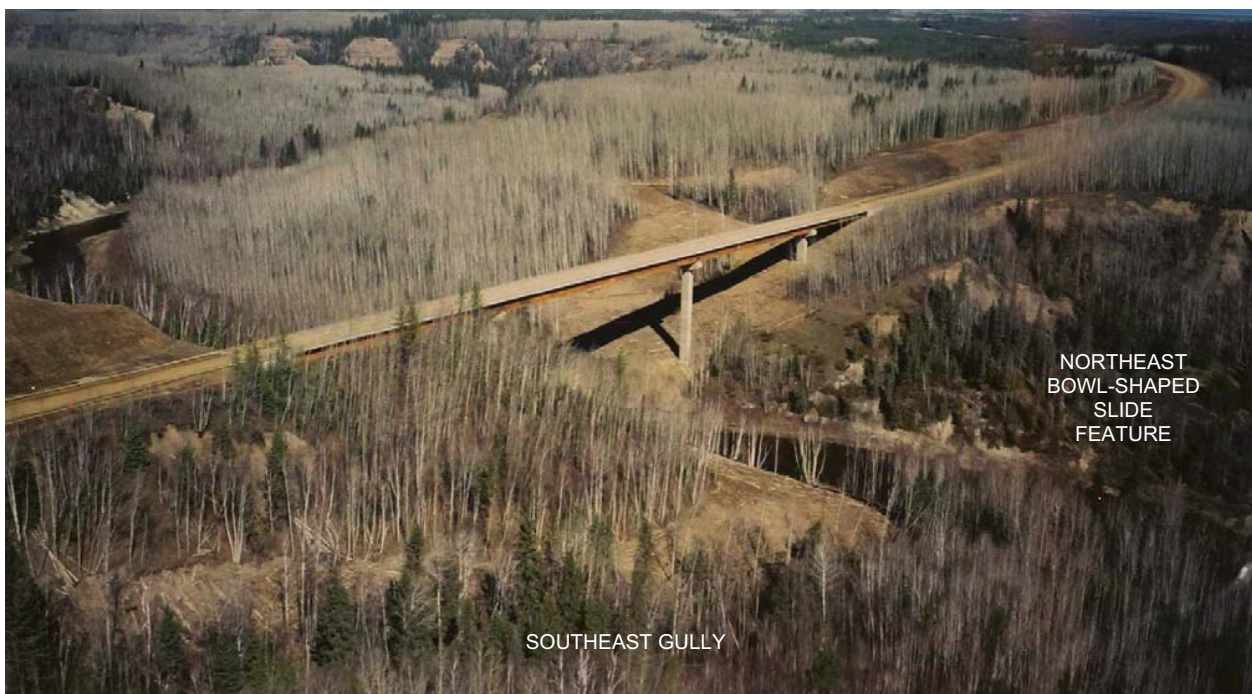
Figure 7. Photo of the Completed Bridge Looking Northwest (note adjacent features)
