REPLACEMENT PIPE DEFLECTIONS UNDER VERTICAL PRESSURE

B. Lapos, GeoEngineering Centre at Queen's—RMC, Queen's University, Kingston ON

ABSTRACT

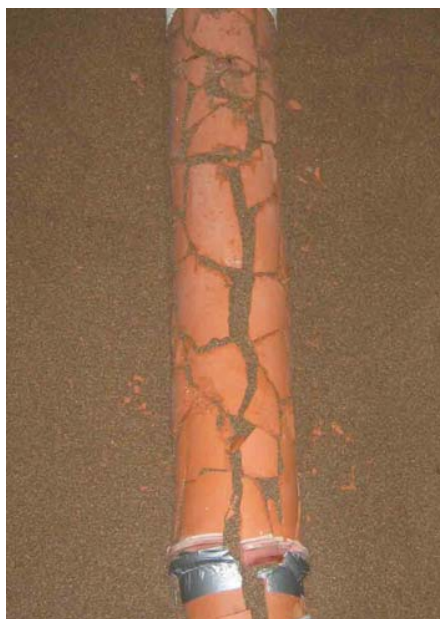
Figure 5. Photograph showing broken clay fragments from Test 2.

Second, upon completion of each test the soil was exhumed down to the pipe level to permit a detailed study of the nature of the broken clay pipe. Air pressure was used to reveal the position of the broken clay fragments without disturbing their orientation relative to the HDPE pipe. Photographs taken following excavation showing the broken clay fragments of replacement Tests 2 and 3 are presented in Figures 5 and 6, respectively.

The fracture pattern observed in Test 2 (Figure 5) differs from that observed in Tests 1 and 3. A pronounced crack (approximately 890 mm long and 30-35 mm thick) was observed along the crown of the clay pipe that was filled with sand, preventing direct contact between the clay fragments above the HDPE pipe. It is further hypothesized that the reduced contact between the broken clay fragments leads to greater loads reaching the pipe (relative to Tests 1 and 3) and hence larger pipe deflections. The reduced contact between fragments likely also explains the shorter offset in deflections for Test 2 relative to 1 and 3.

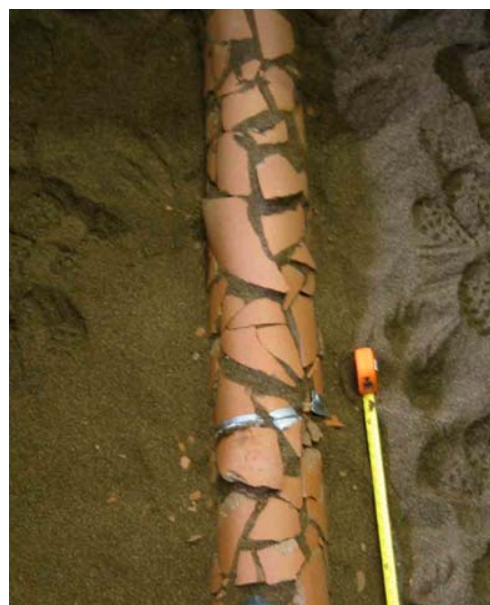
Figure 6. Photograph showing broken clay fragments from Test 3.

The fracture pattern observed in Test 3 is similar to that observed for Test 1. For Tests 1 and 3 the broken clay fragments were in contact with each other at many locations along the pipe, as shown in Figure 6. Several locations where the gaps between clay fragments were filled with sand were also observed. It is hypothesized that at low applied pressures the clay fragments in contact are able to sustain some load; thus the load acting on the HDPE pipe is small and there is little deflection of the HDPE pipe. As applied vertical loading increases the clay fragments begin to move relative to each other, allowing transfer of load to the HDPE pipe. It is believed that variations in measured deflections arise from the variable contact conditions between fragments.

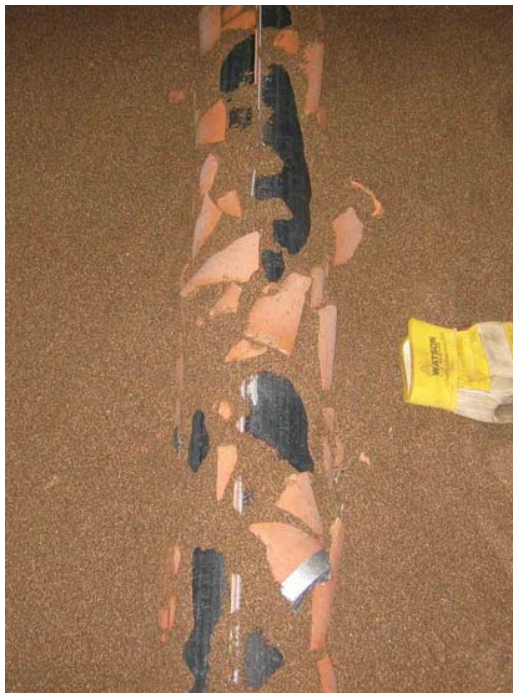
Figure 7. Photograph showing broken clay fragments from Test 4.

A photograph of the broken clay pipe fragments for upsize Test 4 is shown in Figure 7. The broken clay fragments produce different fracture patterns than those seen with the replacement tests. Unlike the replacement test, the clay pipe fragments do not encase the HDPE pipe or provide additional hoop strength. The smaller clay pipe was broken into much smaller fragments, and displaced

radially around the new HDPE pipe, suggesting that the clay pipe has not provided any additional hoop strength. No sounds were heard during any vertical pressure increase, reconfirming that no interaction of clay fragments occurred. When no interaction of the clay fragments occur, the delay in measured diameter change appears to be arise from expansion and subsequent contraction of the soil cavity around the pipe during he pipe bursting process. Diameter change at low vertical pressure is not detected since compression of the soil locally around the HDPE pipe occurs. This phenomenon was also seen in Test 2 which explains the delay in measured diameter change where clay fragments surrounded the HDPE pipe but were not in contact with each other.
