# Geohazard Reviews of Highway Corridors Through Mountainous and Foothills Terrain, Southwestern Alberta

Alberta Transportation has completed geohazard reviews of the Highway 40/541, 742 and 940 corridors in the Front Ranges and Foothills of southwestern Alberta. The purpose of this work was to gather information on the geohazards present along the corridors and the associated risks to the highways that have not been assessed to date under Alberta Transportation's Geohazard Risk Management Program for the provincial highway network. The information from the reviews has been used to estimate the Risk Level for these sites and prioritize them amongst other geohazard sites currently being monitored by Alberta Transportation. This paper discusses the geohazard conditions along these highway corridors, the methodology for the reviews and summarizes the results and their application.

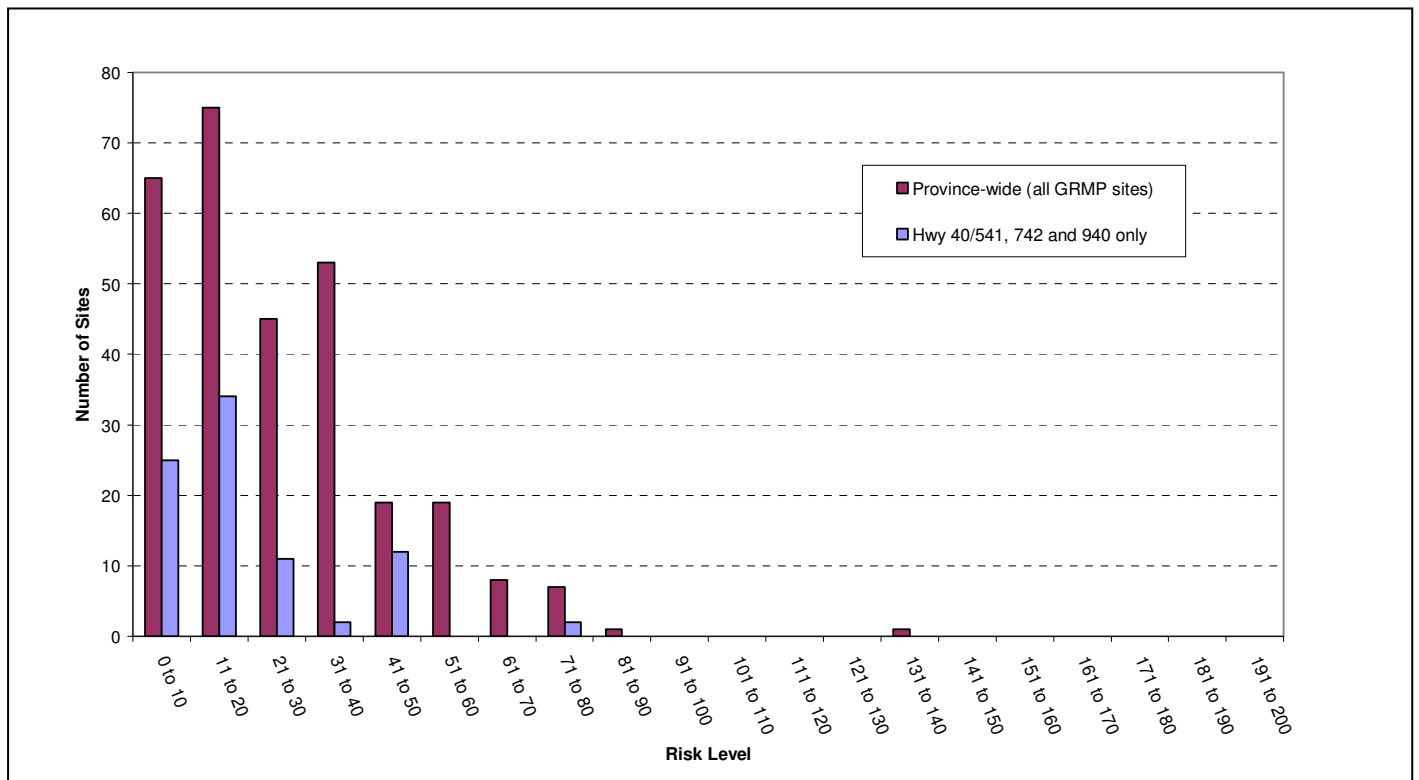
Figure 6. Histograms of Risk Levels for identified geohazard sites.

A histogram of the Risk Levels for the identified sites along Highways 40/541, 742 and 940 is provided in Figure 6, along with a histogram for AT's entire GRMP site inventory for comparison. Of note, no sites with multiple hazard types were found during the Highway 40/541, 742 and 940 corridor reviews and it was not necessary to cumulate the Risk Levels from individual hazards at any site.
