# Real-Time Monitoring for Embankment Construction overtop of Regina Clay

This paper presents the result of real-time monitoring for embankment construction overtop of Regina Clay. Two embankments were built in fall 2009 as a part of the Lewvan Interchange Overpass development on the SW side of the Regina, SK. The settlement profile and pore-water pressures were monitored in the foundation soils prior to construction, during construction and post construction. This paper documents the geotechnical site characterization, predicted settlement based on initial design, embankment construction detail and the results of monitoring program.

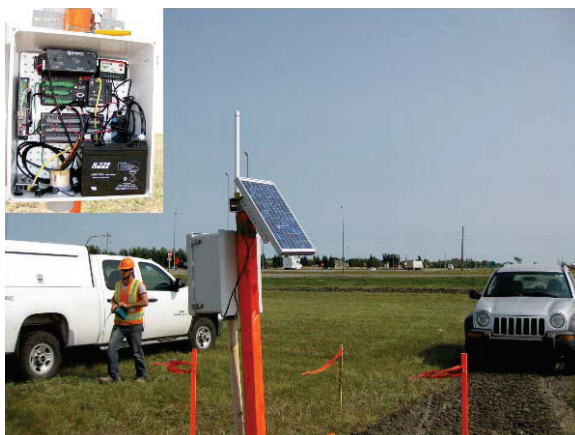
Photograph 1. Remote monitoring station setup.

During the initial construction planning phase, the embankments were proposed to be built around the clock due to a tight completion deadline. Therefore, a real-time monitoring system (ARGUS) was utilized to closely monitor the foundation response due to loading during and post construction. One sub-station was setup, south of existing Highway No. 1 and the main communication station was setup north of Highway No. 1. Photograph 1 shows the remote monitoring setup used in the Lewvan Interchange project. The cables from the vibrating wire piezometers and SAA were routed to one of the monitoring stations.
