# Horizon Dam Design, Construction and Quality Management

Canadian Natural Resources Limited's Horizon Project is located approximately 70 km north of Fort McMurray, Alberta. Horizon Dam is a 30 m high structure constructed as part of the project. The dam is required to divert the Tar River around the tailings pond and to replace fish habitat as compensation for impacts of the mine and plant construction. The dam is a zoned earth fill embankment with a detached outlet and overflow spillway. This paper will discuss the following challenging aspects of the project construction that had to be overcome by Canadian Natural and their design consultants:

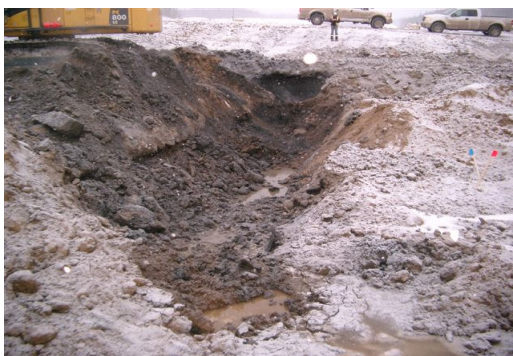
Figure 6. Permeable Alluvial Deposits

contingency for pumping wells. During construction of the cofferdam, localized zones of gravel and cobbles with high permeability, shown on Figure 6, were observed in the foundation of the Tar River Cofferdam. Investigations undertaken to assess the foundation conditions and establish appropriate remedial measures confirmed the existence of permeable deposits with hydraulic conductivity up to four orders of magnitude higher than the average value assumed for design.

Based on the adverse foundation conditions encountered, and the lack of experience of the mining construction team with specialized dam construction, the seepage control design was modified. Two alternatives were considered: (1) construction of a slurry wall or (2) installation of pumping wells. Based on both the estimated cost and constructability considerations, the slurry wall was selected as the preferred alternative. The slurry wall also allowed eliminating the cutoff trench provided in the original design for the main dam
