Design and Construction of a Seepage Cut Off Wall Using The Slurry Trench Technique in Cold Temperatures at the Horizon Dam Project

L.A. Barr and J.C. Sobkowicz
Thurber Engineering Ltd., Calgary, AB, Canada

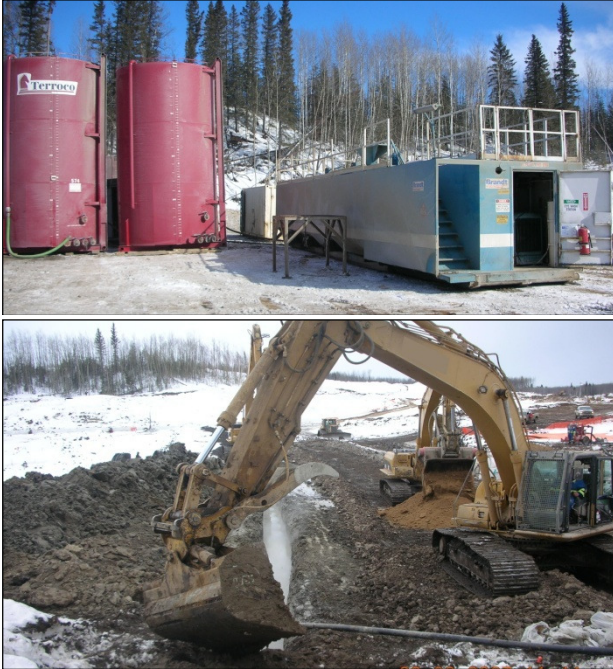
Figure 10. **Above:** Batch Plant, **Lower:** Slurry Wall Construction.

The methods described above were effective in protecting all materials during and after construction, and were integral in the successful completion of the cut off wall. Figure 10 presents the batch plant set-up and construction of the cut off wall.
