GEOQuébec  
2015

# Stability design of a tailings dam on a glaciolacustrine clay foundation

Jérôme Lapierre, Desheng Deng, Gilles Bouclin & Luciano Piciacchia  
Amec Foster Wheeler, Dorval, Québec, Canada

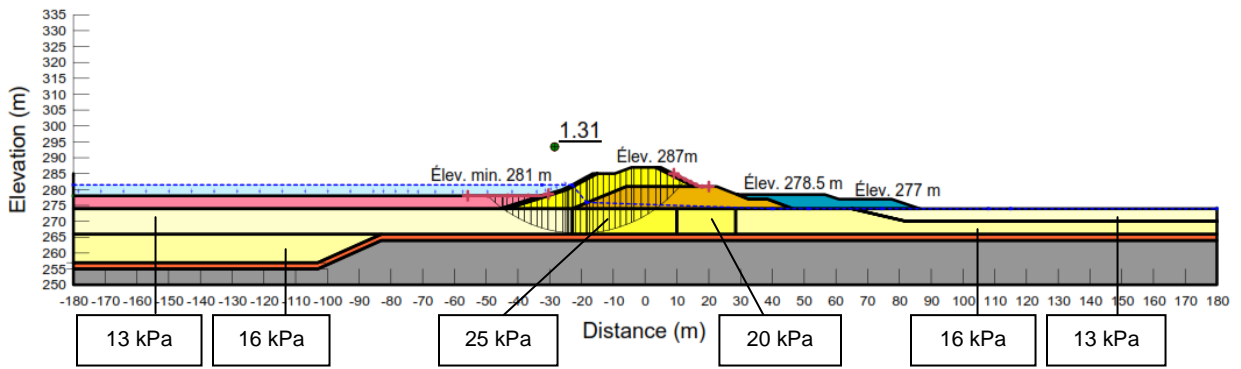
Figure 2. Year 1, undrained, upstream stability analysis

The undrained shear strengths presented in Table 4 were measured using vane shear tests in two boreholes downstream of the existing dam. In the Year 1 stability analyses, the lowest values (13 and 16 kPa) found in each downstream borehole were used, except under the existing dam (see Figure 2 and Figure 3).

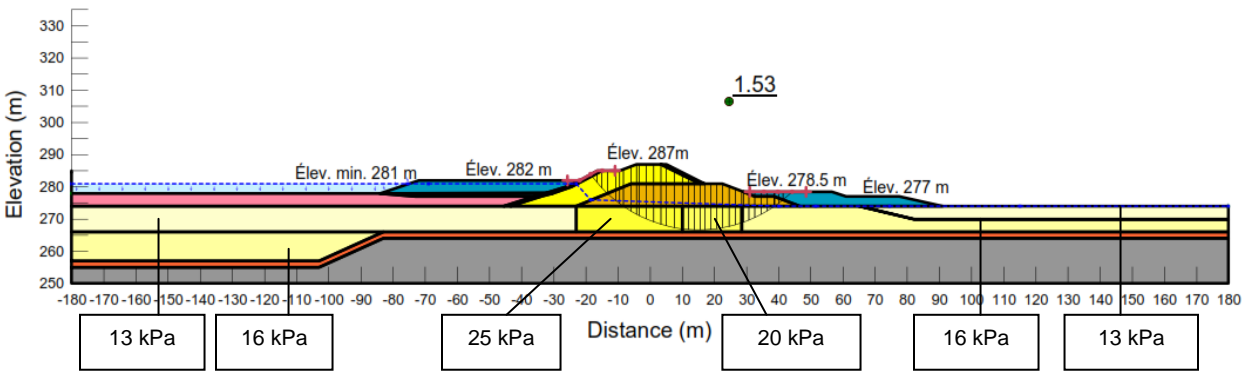
Figure 3. Year 1, undrained, downstream stability analysis

Minimal work is planned for Year 1, as more geotechnical information is required before starting further stages. Thus, part of the downstream berm will be built first in order to reach a factor of safety of 1.53 for the downstream slope of the existing dam, as illustrated in Figure 3. Once this is done, the water level in the existing basin will be slowly lowered, but not below elevation 281 m. This is necessary to maintain a factor of safety of 1.31 in the upstream direction (see Figure 2). Then part of the upstream berm will put in place in the existing basin, starting from the shore and up to elevation 282 m. With both slopes of the existing dam secured, the upstream berm will be used as a platform to perform additional geotechnical investigations.

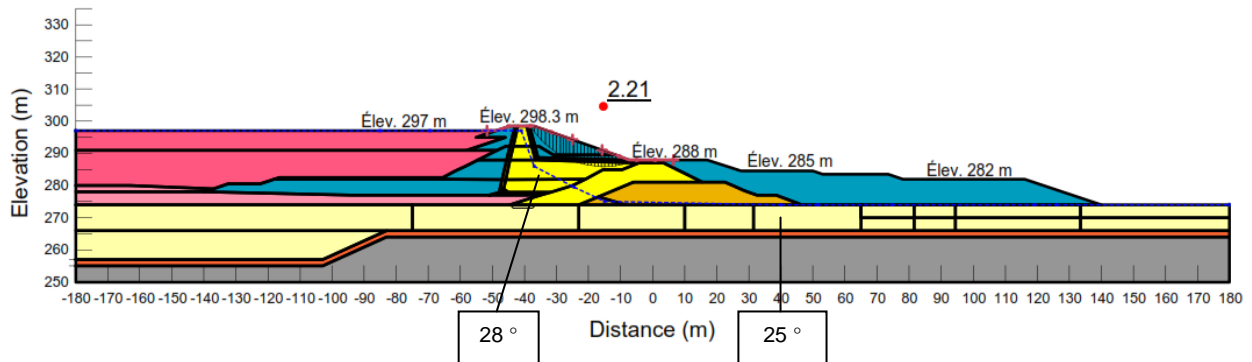
Figure 6. Long-term, drained, downstream stability analysis

The end-of-life of the TMF is presented here, with the crest and tailings reaching final elevation at 298.3 m and 297 m respectively. The downstream berm is extended in order to reach a factor of safety of 1.52 in undrained conditions, as shown in Figure 5. For long-term fully drained conditions, a factor of safety of 2.21 is obtained, as shown in Figure 6.
