# Use of rock fall nets on Canadian National Railway – Design constraints and solutions

Mark Pritchard BGC Engineering Inc, Vancouver, British Columbia, Canada Tim Keegan BGC Engineering Inc., Edmonton, Alberta, Canada Tom Edwards Canadian National Railway, Edmonton, Alberta, Canada Allen Benson BGC Engineering Inc., Vancouver, British Columbia, Canada Steve Mumma Geobrugg North America, Geobrugg North America, Lake Oswego, Oregon, USA

# ABSTRACT

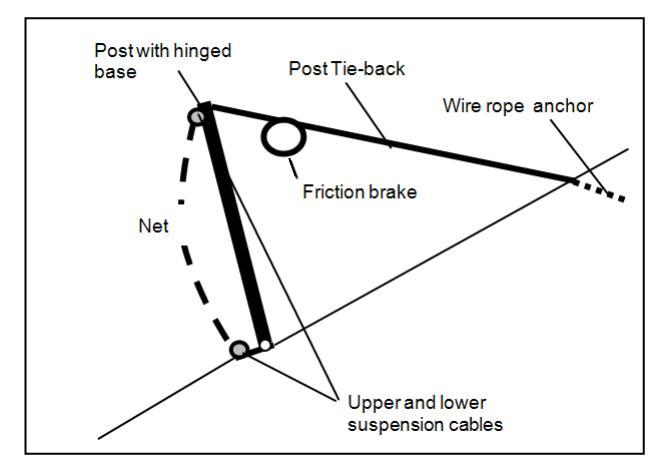
Figure 1. Schematic cross section of a rock fall net system

Rock fall nets are flexible barriers that are designed to intercept and arrest rock fall. They are typically fences of cable mesh or interlocking bundled wire rings (ring nets) raised off the ground by steel posts and suspension cables. Additional tie-back cables are also typically used. Figure 1 illustrates the basic components of most rock fall net systems.

When impacted, rock fall net systems absorb impact energy by transferring load from the net panels to the suspension cables, and from those cables to the suspension cable ground anchor points and the post tieback cables and ground anchors. To dissipate the rock fall energy into the system over a longer period of time and reduce the forces in the system components, frictional breaking elements are typically included in the suspension cables and tie-back cables.

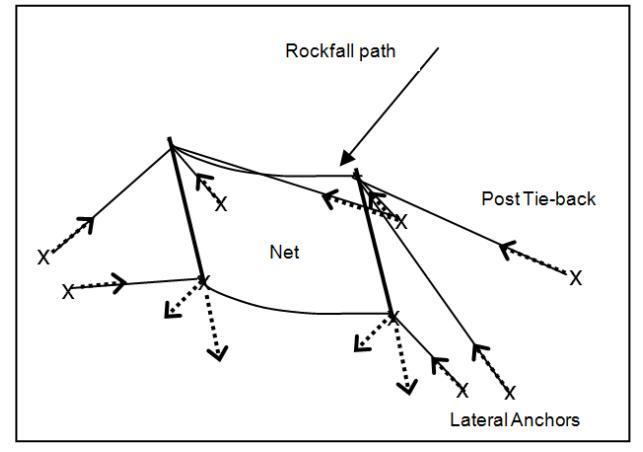
Figure 2. Isometric schematic of rock fall net ground forces. "X" denotes ground anchors, arrows are forces exerted on the ground by the rock fall net system.

Figure 2 illustrates the typical ground forces induced by a rock fall system when impacted. It is important for the designer to understand the ground forces produced by the system to check that there will be adequate bearing capacity and shear resistance of the post foundations, and adequate uplift restraint on lateral and tie-back anchors. The overall slope stability of the system under the applied forces also has to be considered. The design forces for the system should be provided by the manufacturer, and should be the result of measurements during full scale testing of the system.

Foundation conditions are a key consideration when evaluating the suitability of a site for rock fall net installation, and may also limit the possible energy capacity of a system. Figure 2 illustrates typical rock fall net foundation forces. Design ground anchor force magnitudes vary with the rock fall net system capacity, but can be in excess of 500 kN for a 3,000 kJ system. Ground anchors need to have sufficient embedment to resist failure of the grout to anchor and grout to rock or soil bond, and sufficient ground restraint to not cause ground rupture when loaded. Multiple anchors attached to a plate at the surface can be used to distribute the load and reduce the capacity required on a single anchor and thereby reduce the required anchor size, borehole diameter and drill size. Site topography, such as gullies, can influence anchor placement as the designer seeks to maintain sufficient ground cover over the anchor bond zone to resist anchor breakout.

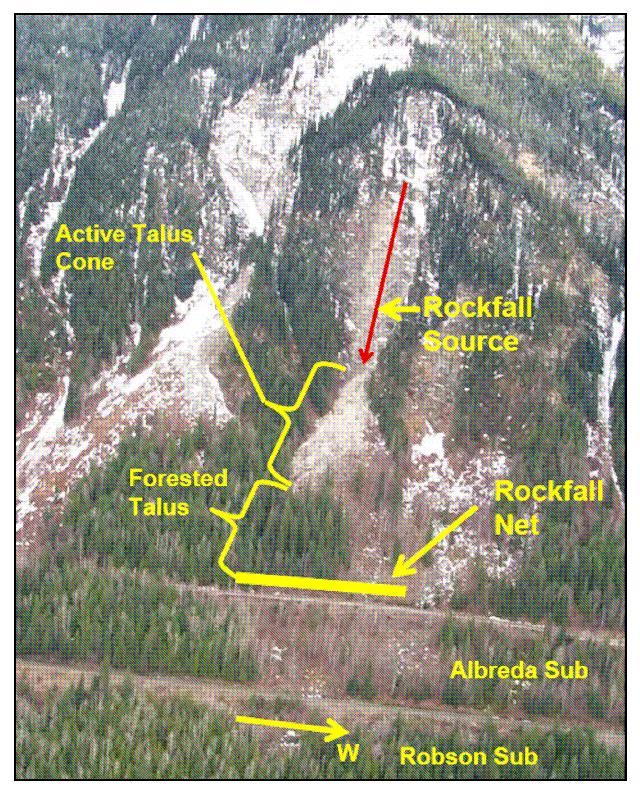
Figure 3. CN Albreda Sub. Mile 53.2. Aerial view looking south at the north slope of Mt. Klapperhorn showing the rock fall source, slope geometry and track locations. Photo: T.Keegan.

The CN Albreda Subdivision begins at Jasper, Alberta and extends west through the Rocky Mountains to Blue River, British Columbia. Between about Mile 52.5 and Mile 55 of the subdivision the rail line traverses talus slopes near the base of the northern slope of Mt Klapperhorn. Through this area, the CN Robson Subdivision is parallel to the Albreda Subdivision, but about 30 m lower in elevation on the slope. Figure 3 illustrates this general arrangement.

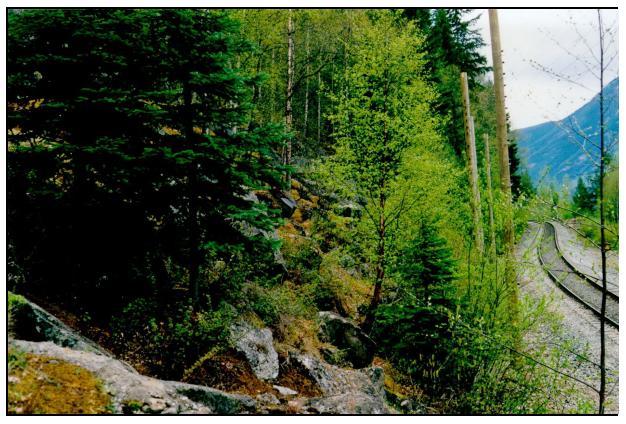
Figure 4. View looking west along lower talus slope above CN Albreda Subdivision Mile 53.2 showing large talus, minimal ditch, and slide detector fence. Photo: M. Pritchard

Mt. Klapperhorn produces rock fall, and at Albreda Subdivision Mile 53.2, rock falls are funnelled into a rock spur bounded talus chute that opens onto a talus fan and apron at the base of the mountain. The channelling effect of the rock chute has created a defined talus cone and rock fall path. Figure 3 provides an overview of the site, while Figure 4 illustrates the near track conditions prior to work.

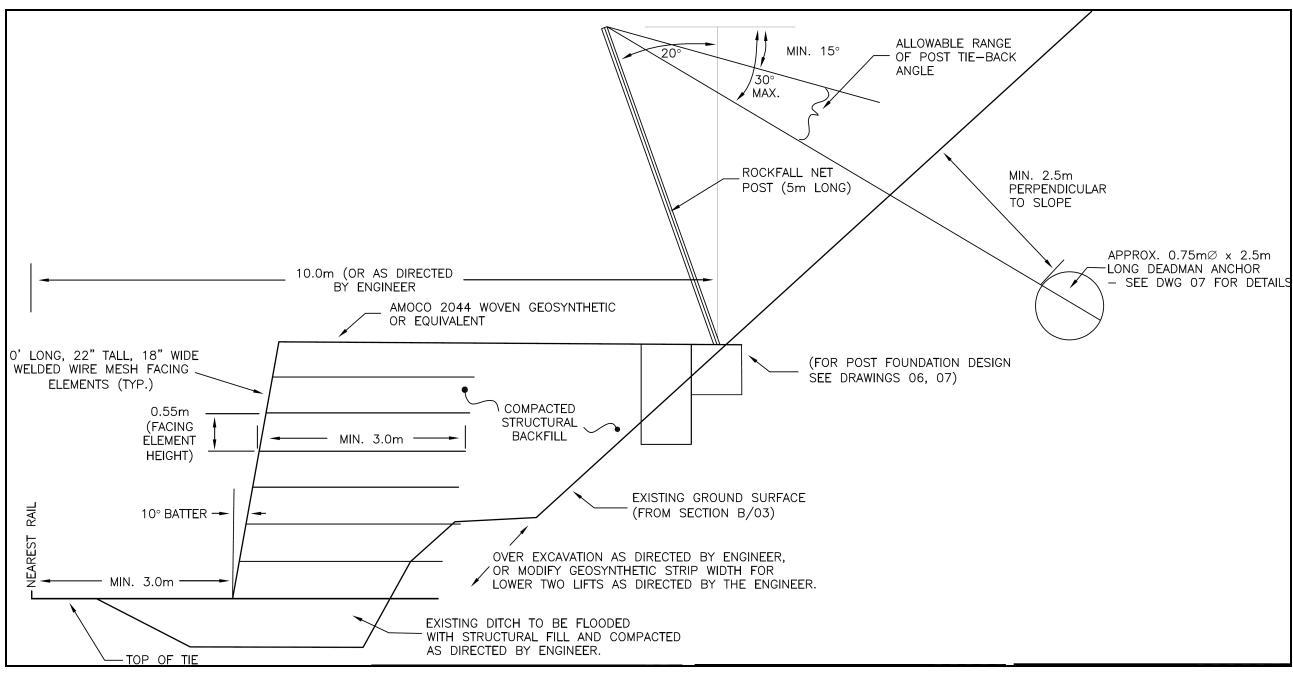
Figure 5. CN Albreda Sub. Mile 53.2. Typical section illustrating GRS wall, post foundation, and post tie-back arrangement

The solution adopted for the location of the rock fall net system was to construct a geosynthetic reinforced soil (GRS) wall founded at the up slope side of the ditch as a platform for the post foundations. The wall height was varied as dictated by the up slope topography to maintain a constant bench width on the top of the GRS wall. The desired bench width was dictated by the need to provide post foundation locations in the wall fill, and having the post foundations at least 7 m from the track that the activated fence would not affect the train clearance envelope. Figure 5 illustrates this concept.

Ground anchorage and down slope shear resistance for the post foundations was achieved by mounting the base plate for each post on a concrete lock-block (dimensions  $1.5 \text{ m} \times 0.6 \text{ m} \times 0.6 \text{ m}$ ), and setting each block behind two other lock-blocks that had been bolted together and set into the GRS structure to form an inground wall 1.5 m tall, 1.2 m wide and 0.6 m thick. This arrangement provides passive earth resistance against horizontal shear of the post base in a down slope direction. It also provides uplift resistance equal to the weight of a lock-block, although the latter was not part of the design loading criteria for the posts. Formed concrete was not used for the post foundations because of the complexity of mobilizing batched concrete to the site with uncertain and unpredictable track time combined with highway travel time from the nearest concrete plant.

Rock fall net suspension cables (upper and lower) required lateral anchors, and posts required tie-back ground anchors. Lateral anchors were achieved by burying deadman anchors in the GRS wall. The post tieback ground anchors used the same deadman anchor, but installed in the talus slope uphill. Figure 5 illustrates the post tie-back arrangement. For deadman anchors, scrap concrete railway ties, which are heavily steel reinforced, were bundled to make an anchor with approximate dimensions of 0.6 m diameter and 2.4 m long.

The GRS system used consists of an "L" shaped weldmesh facing element with Amoco 2044 woven geosynthetic at 0.28 m vertical spacing. Fill was locally available well graded sand and gravel, well compacted. Design of the GRS wall was provided by Terratech Consultants Ltd.

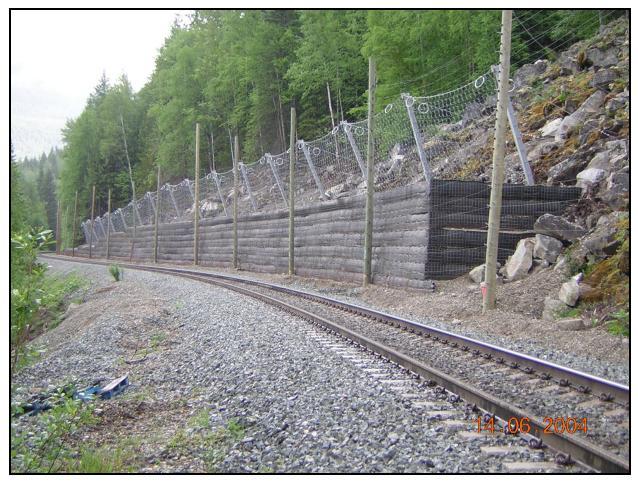
Figure 6. View looking east from the west end of the completed GRS wall and rock fall net system, CN Albreda Subdivision Mile 53.2. Photo: C. VanBuskirk

Figure 6 illustrates the completed system. Innovations with a GRS wall provided a platform that allowed the rock fall net system to be placed clear of the train envelope, and the use of deadman ground anchors and modular concrete post foundations were successful in overcoming the combined constraints of the rock fall net system design requirements and the site characteristics. A successful rock fall net installation was achieved that otherwise would have been very difficult to construct and resulted in much more extensive site disturbance.

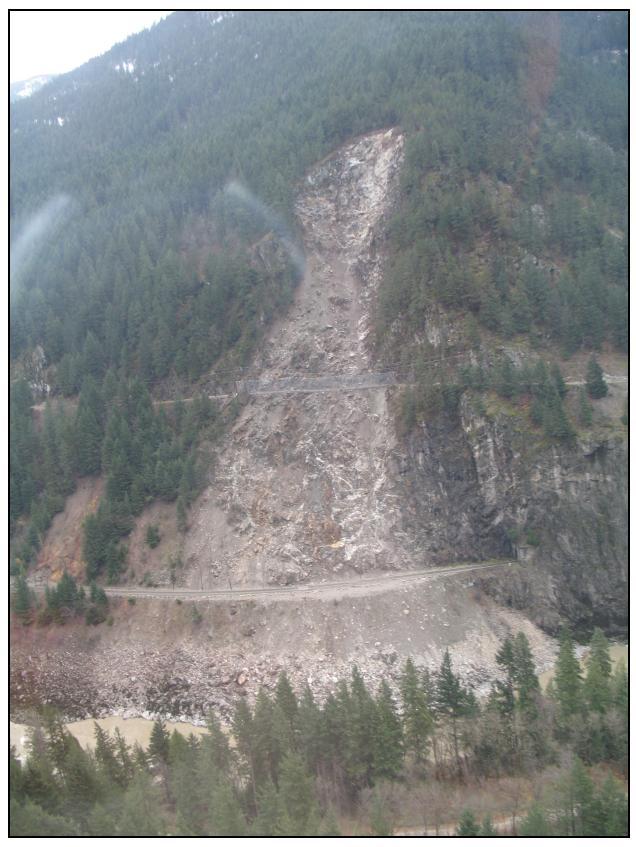
Figure 7. View looking east across the Fraser Canyon at CN Yale Subdivision Mile 5.3 and the China Bar Slide. Photo: T. Keegan

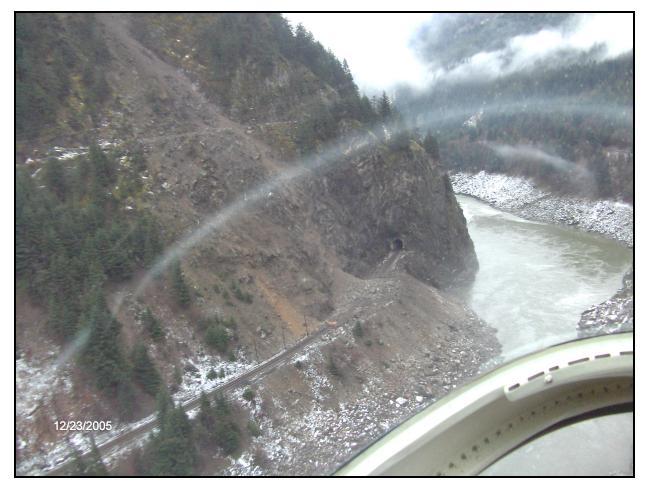
Figure 8. CN Yale Sub. Mile 5.3. View looking south at December 23, 2005 rock slide debris. Photo: D. Allen

On December 23, 2005, an approximately 700 m<sup>3</sup> rock slide occurred from the head scarp of the ancient rock slide, burying the track as illustrated in Figure 8. Residual smaller rock fall occurred for several days. For the safety of personnel, track clearing and repair was not attempted during this period. The track was closed for five days while residual rock fall risk was assessed and minor scaling at the slide head scarp was undertaken. Once the track was cleared by rock guarded equipment, it was still considered too dangerous for unprotected personnel to repair the slide detector fence. The fence was not repaired, but the track was in service for freight traffic only and under protection of a 24 hour watchman and with trains travelling at restricted speed (able to stop short of an obstruction).

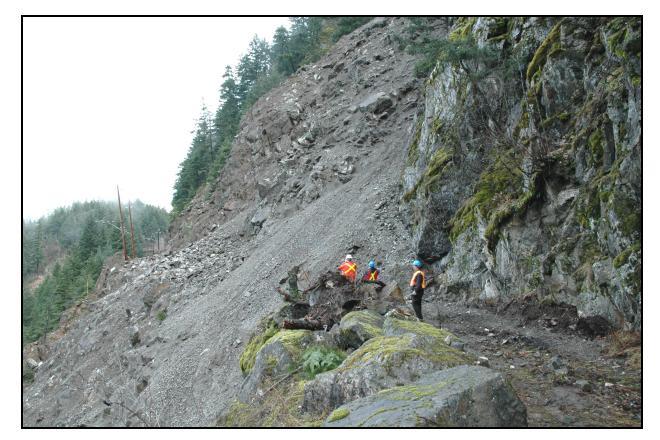
Figure 9. CN Yale Sub. Mile 5.3. View looking north along old highway prior to construction. Photo: T. Keegan

Figure 9 illustrates the condition of the old highway in early January, 2006. While the old highway provided a convenient bench with easy access from Highway 1, laydown areas, and a level installation surface accessible to machines, some characteristics of the site were problematic. Rather than a uniform rock ledge, the old highway was a gullied bench with old timber crib retaining walls placed as fill in gullies. Restoration of one wall was required for access and installation of the rock fall net. Design required spacing the posts along the road edge to avoid gullies while meeting the 8 m to 12 m post spacing constraint. The BC Hydro power pole at the north end of the installation was down slope of the last net panel, and extension of the net system during an impact would have knocked this pole over. This pole was replaced with one further north. With the rock fall net installed, the clearance of the system to the power lines would not meet BC Hydro guidelines. This was addressed by installing taller power poles at either end of the system.

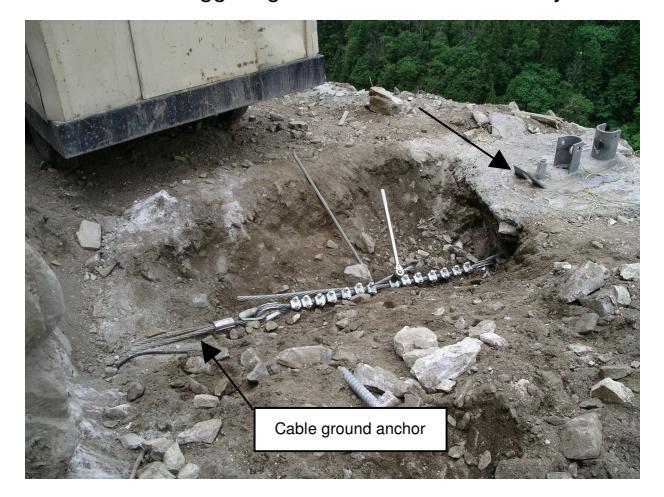
Figure 10. CN Yale Sub. Mile 5.3. Photograph of post foundation utilizing tie-back to ground anchor in old highway cut slope. Photo: A. Benson

Post foundations were designed to be two 43 mm diameter 517/690 MPa, five metre deep threadbar anchors in rock with a nominally 0.30 m thick seating pad of reinforced concrete for the base plate. For several of the post foundations, the rock mass was too dilated to successfully drill or grout in the threadbar anchors or the rock mass on the highway shoulder was not considered strong enough to resist the design down slope horizontal load. In these cases, the design was modified to deepen and further reinforce the concrete base for the pad, and tie back the post pad to the old highway cut slope. The post tie back was accomplished by including a horizontal threadbar into the concrete pour that projected from the up slope side of the foundation, installing a cable anchor into the toe of the highway cut slope, and extending that cable anchor to connect to an eye on the threadbar. Figure 10 illustrates this arrangement. Figure 11 illustrates the site during rock fall net foundation construction.

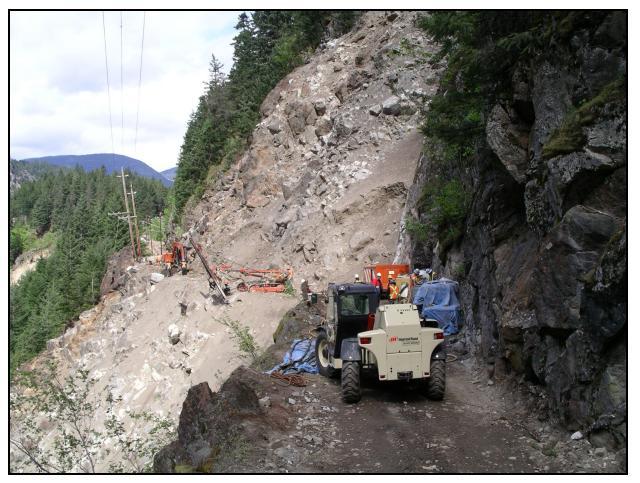
Figure 11. – CN Yale Sub. Mile 5.3. View looking north along old highway during rock fall net foundation construction. Photo: M. Pritchard

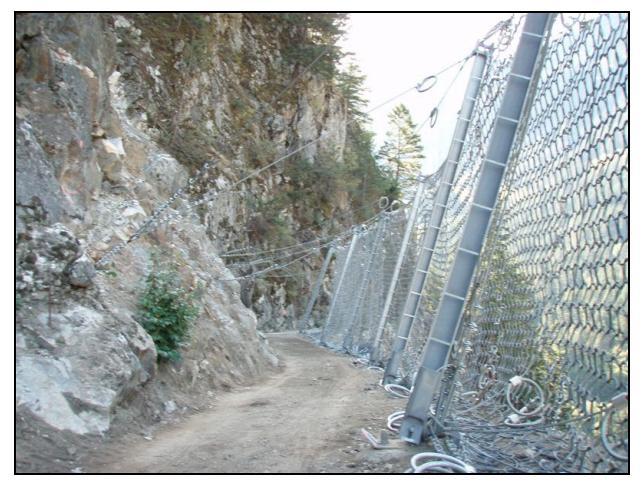
Figure 12. CN Yale Sub. Mile 5.3. View looking south along old highway from middle of completed rock fall net system. Photo: C. Laughlin

Figure 12 illustrates the completed rock fall net system. The system is an example of the use of a rock fall net to augment other protection systems, with the understanding that the rock fall net is not designed to intercept all rock fall, and may be overwhelmed by the largest potential rock fall. In this case, the reduction in service disruption potential and the improvement in worker safety were considered worthwhile.
