Use of residual shear strength parameters for slope stability analysis against surficial failures

Venkata S. Dronamraju, Anand J. Puppala & Sarwenaj Ashraf The University of Texas at Arlington, Arlington, Texas, USA

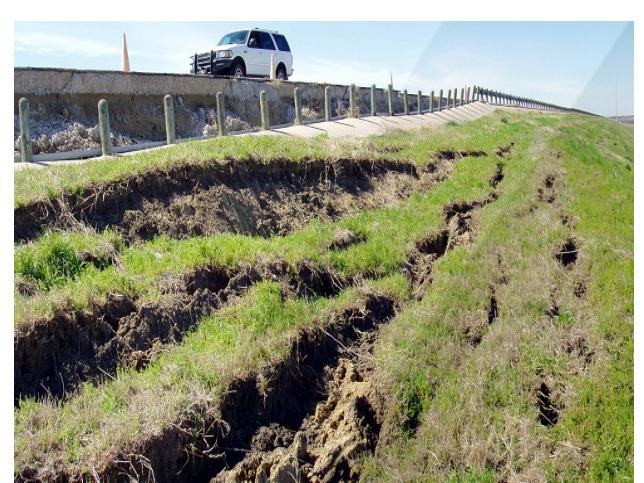
Figure 1. Surficial Failure of Joe Pool Dam, USA

A typical surficial failure that occurred at Joe Pool Dam in Texas, USA is shown in Figure 1.

Joe Pool Dam is located 15 miles southwest of Dallas in the state of Texas in USA. The dam was constructed between 1979 and 1986 and impounding started in January 1986. The length of dam is about 7.4 km and maximum height of dam is 33 m. The dam has a down stream side slope of 2.8H:1V (20°). The soil of the dam is classified as CH soil and it has a Plasticity Index of 37. The activity of the soil is around 3.2.

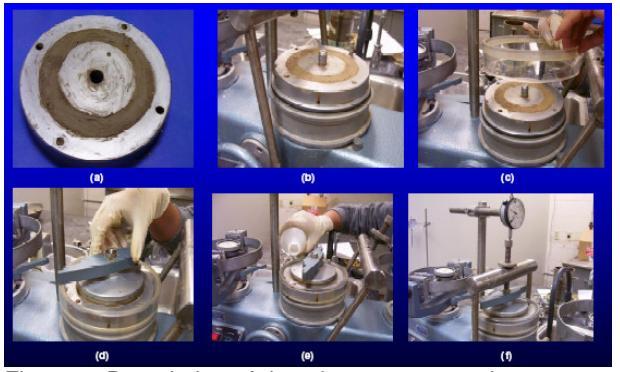
Figure 2. Description of ring shear test procedure

The equipment contains a Bromhead torsion ring shear device. The preparation of soil specimen and the set up for preconsolidation is shown in Figure 2. Soil specimen is prepared at a water content equal to the liquid limit and placed in the annular space of the bottom platen and the top platen is placed over it.

The specimen is pre-consolidated under a water bath at a load increment ratio of one at applied normal stresses of 25 kPa, 50 kPa, 100 kPa, 200 kPa and 400 kPa. For each load increment, it was ensured that primary consolidation was complete. In order to reduce the amount of horizontal displacement required to reach a residual condition, the specimen was pre-sheared at a constant rate of displacement of 18 mm/min.

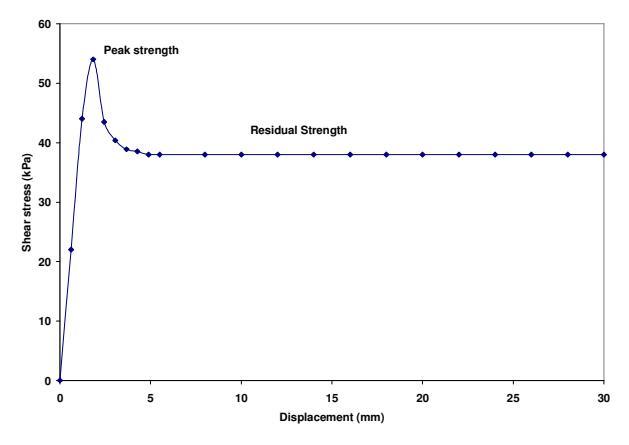
Figure 3. Displacement vs. Shear stress plot for soil at a normal stress of 100 kPa

Torsion ring shear tests were performed on the Joe Pool Dam soil. A typical test result showing the peak and residual values of soil is presented in Figure 3.

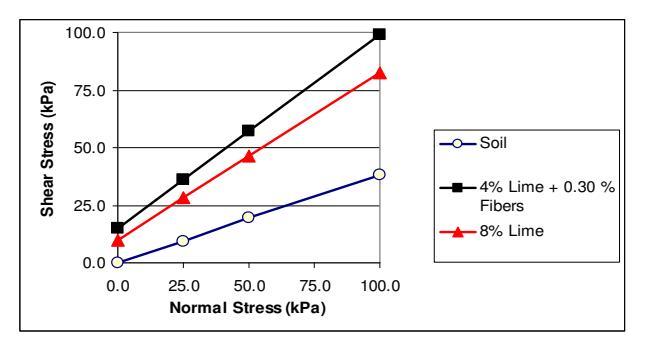
Figure 4. Drained residual shear strength parameters

Test results indicated that the cohesion is approaching zero at low normal stresses and the drained friction angle is close to 20[°] as shown in Figure 4.

factor of safety less than 1. As such, it was planned to strengthen the soil of Joe Pool Dam by adding admixtures to soil. Tests were hence performed on soils mixed with various proportions of lime and polypropylene fibers. Typical results for soil with admixtures of 8% lime and 4% Lime with 0.30% polypropylene fibers is also shown in Figure 4.

Addition of admixtures has improved the drained residual shear strength parameters. A drained residual cohesion of 10 kPa for 8% Lime and 15 kPa for 4% Lime with 0.30% fibers was obtained. The drained friction angle was observed to be 36[°] for 8% Lime and 40[°] for 4% Lime with 0.30% fibers.

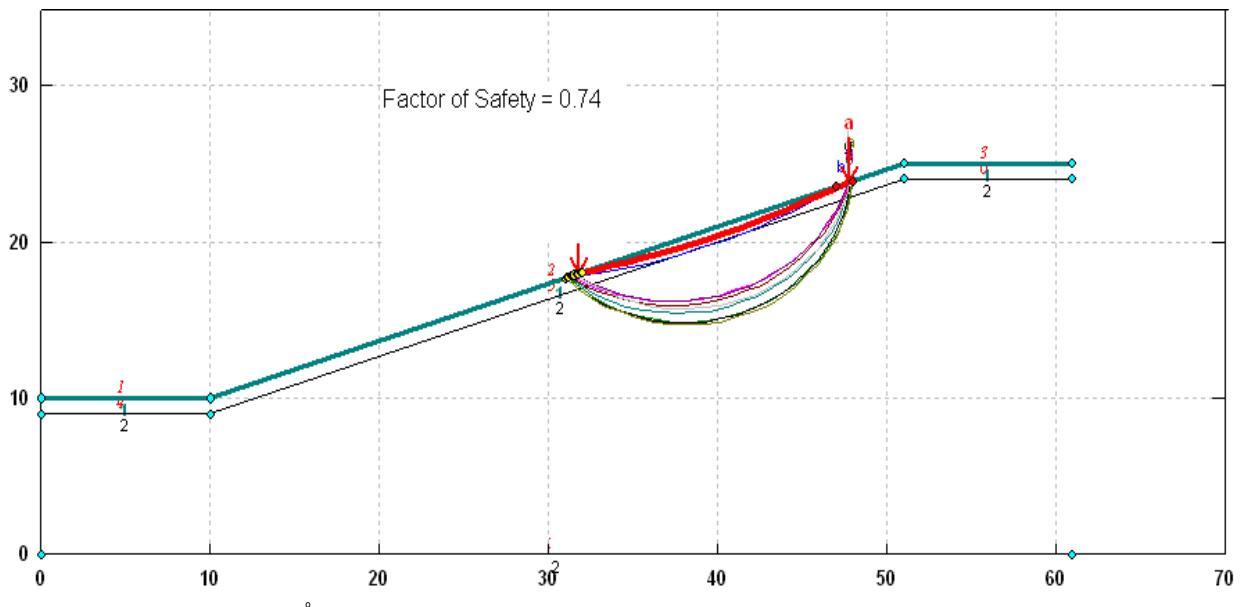
Figure 5. Failure circle for 20° slope with 1 m desiccation zone and length of failure less than 18 m

To obtain the maximum length of failure surface, the interval between initiation point and termination point was increased. Figures 5 and 6 show the output of stability analyses for a slope of $2.8H:1V (20^{\circ})$ with a desiccation depth of 1 m and embankment height of 15 m.

For the above example, the maximum length of failure was around 18 m. For a length of failure surface less than 18 m, the factor of safety was observed to be 0.74 as shown in Figure 5. When the failure length increases, the failure circle intersected the unsaturated zone and the resulting failure surface was a deep seated failure with higher factor of safety of 6.72 as shown in Figure 6.

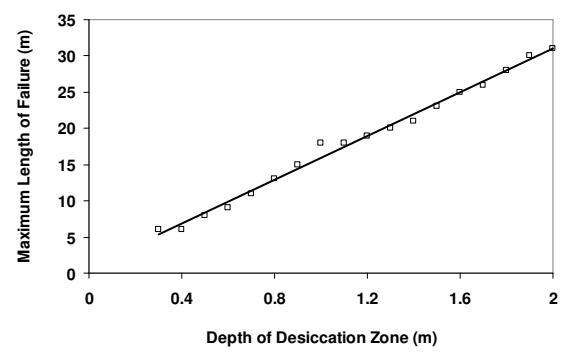
Figure 7. Variation of maximum length of failure for 20° slope

In the similar manner, the maximum lengths of failure for different depths of desiccation zones ranging from 0.3 m to 2 m are computed and these results are plotted in Figure 7.

Maximum length of slope prone for failure is 18 m for 20[°] slopes and this length is reduced to 13 m for 30[°] slopes and around 7 m for 40[°] slopes for a desiccation depth of 1 m. From the stability analyses results, it appears that this maximum length of failure is constant for a given depth of desiccation zone. This is valid for dams whose lengths of slopes are more than the maximum length of failure. In cases where length of slope was shorter, full length of slope is prone to failure. For example, for 6 m or higher embankments with a slope of 20[°] and a depth of 1 m desiccation zone, the maximum length of failure for circular arc type failure is around 18 m. If the height of embankment is less than 6 m, the failure can occur for the entire length of slope.

Majority of the failures were occurred on the down stream side slope nearer to crest. Torsion ring shear tests were performed on soil samples obtained from the dam location near a shallow slope failure. The results have shown a drained friction angle of 20[°] with a zero cohesion value. The extent of failures occurred on Grapevine dam are compared with the results of circular failure analysis. The observed length of failures along the slope is 10 m for 0.6 m deep failure, 14 m for 1.2 m failure and 21 m for 1.8 m deep failure (McClesky, 2005). This indicates that the results shown in Figure 7 closely match with the field observations.

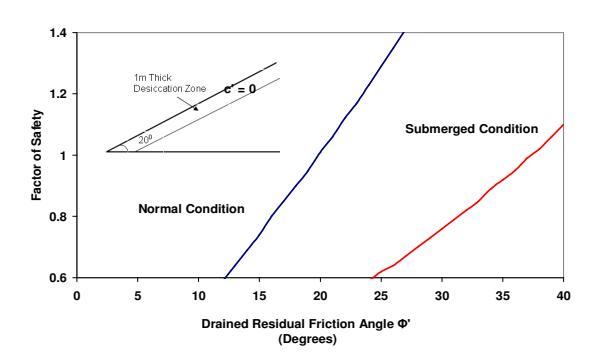
Figure 8. Effect of friction angle on factor of safety

The computer software is further utilised to determine the minimum value of drained friction angle and drained cohesion of soil to ensure that the slope is safe against surficial failures. Slope analysis was performed for the maximum length of failure surface of 18 m and for a desiccation depth of 1m. The analysis is performed for normal condition when the slope is not submerged and for submerged condition. For submerged condition, the water table is aligned along the slope surface for the dam having a slope angle of 20°.

For a 20[°] slope in normal conditions, it is noticed that the minimum drained friction angle (with zero drained cohesion) required to achieve a factor of safety of 1.3 is 25[°]. This factor of safety is reduced when the soil is under submerged condition.

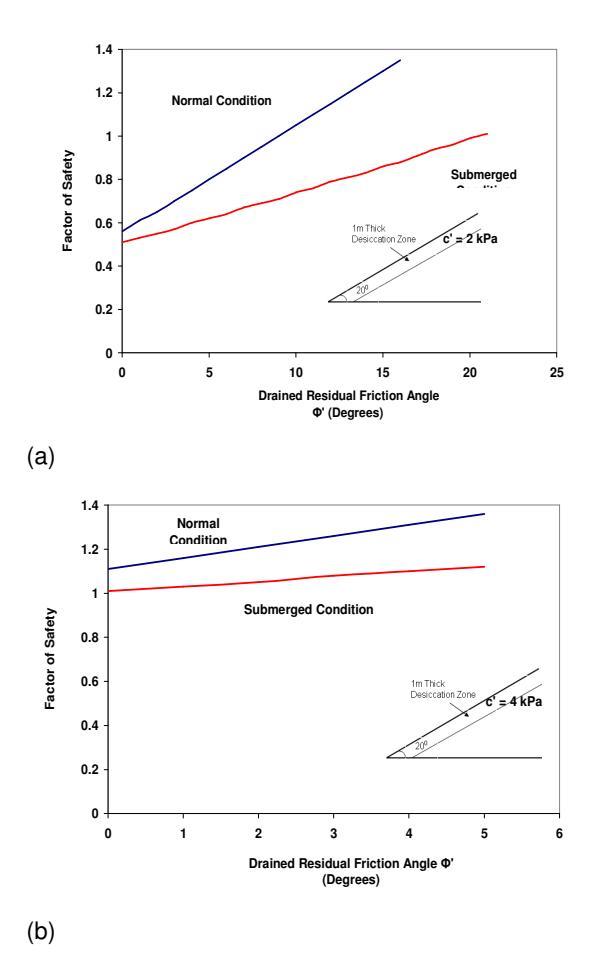
Figure 9. Variation of factor of safety (a) c' = 2 kPa and (b) c' = 4 kPa

Similar analyses were repeated by including drained cohesion parameters. Figures 9 (a) and (b) show the variation of factor of safety with respect to drained friction angle when the drained cohesion is varied from 2 kPa to 4 kPa. In order to achieve the same factor of safety, for the soils having higher cohesion, the required drained friction angle can be small. For a 20° slope, it is noticed that for a minimum cohesion of 5 kPa, a factor of safety of more than 1.3 is possible even with a drained friction angle of zero. As such it can be concluded that under drained conditions failure does not occur as long as soil possesses either drained cohesion of 5 kPa or a drained friction angle of 25° or a combination of both. It is noted that this requirement of minimum drained parameters increases with an increase in slope angle.

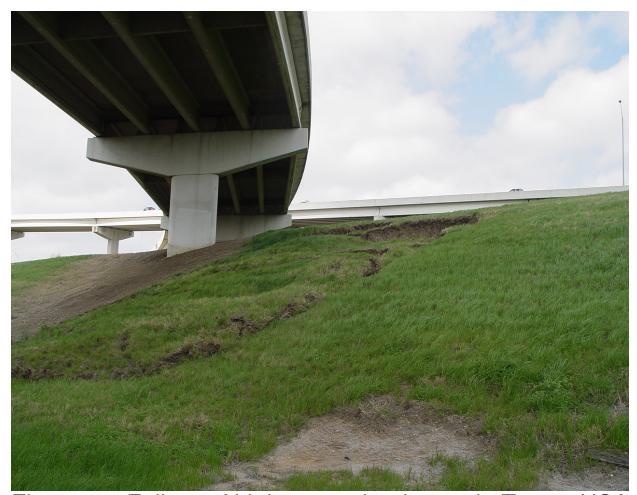
Figure 10. Failure of highway embankment in Texas, USA

The slope is also modelled using a non-circular slip surface assuming the failure surface to be parallel to slope. Field observations reveal that the failures parallel to slope for the entire length of slope are occurring in the case of low height embankments. Figure 10 shows a typical failure photograph where a failure occurred parallel to slope almost for entire length of a highway embankment of an exit ramp in Dallas, Texas, USA.

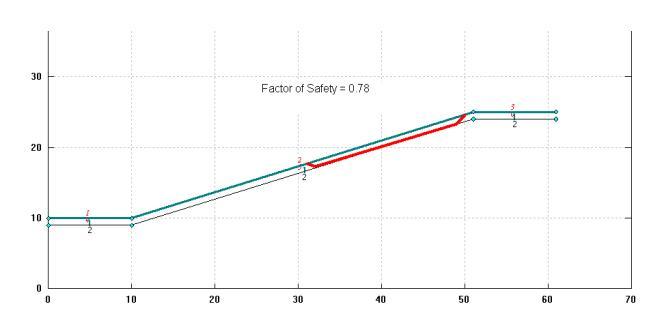
Figure 11. Failure circle for 20[°] slope with failure surface parallel to slope for part length

Using the same computer program, the dam slope is modelled with a failure surface parallel to slope both for a part of the slope (as shown in Figure 11) and for the entire surface (as shown in Figure 12).

The factor of safety in both cases was close to 0.77 and this value was close to factor of safety value of 0.74 which was obtained when circular arc failure analysis was used. This indicated that both wedge type and circular type analyses for surficial failures will yield similar factor of safety values as long as the failure is confined to desiccation zone.
