Some geocryological problems of railways and highways on permafrost of Transbaikal and Tibet

Kondratiev V.G.^{1,2}

¹ Chita State University, 672039, Aleksandrivozavodskaya ul., 30, Chita, Russia;

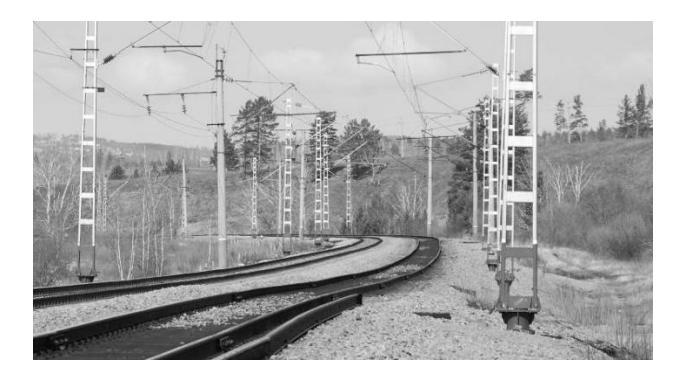
Figure 1. Deformations of a track of Transbaikalian Railroad, km 6278, March, 2009

One of the major problem areas on the Transbaikalian Railroad, located at route segment 6277 to 6278 km, is shown in Fig. 1.

This segment is known as the "golden" kilometer. At this location, continuing deformation of the embankment and rail-sleeper grating has been occurring since 1949. Train speed limitations of 40 km/h, and sometimes as low as even 15 km/h, have been imposed since 1969, while addition of ballast and rail adjustments are executed annually.

In some places, the ballast has already subsided 5 to 6 m and subsidence of the rail bed has not ceased. This condition is expected to continue for many years, since the embankment was constructed on permafrost soils having a thickness of 25 to 30 m.

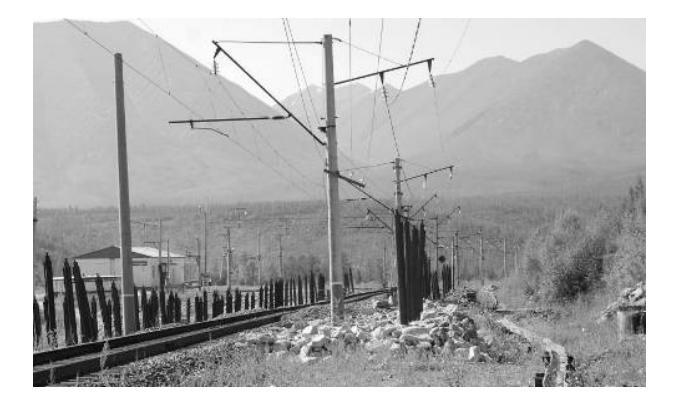
Figure 2. Area of severe deformation on the East-Siberian Railroad at 1374 km of BAM, August, 2008

On the East Siberian Railroad in the region of the Kazankan sidings at 1374 km on the BAM, major railway track deformation has been taking place for nearly two decades. From the original four track lines on this segment, only one remains in service; however, as shown in Fig. 2, it also requires nearly continual maintenance and recurrent refitting. For the last seven years, 360 million rubles (about 15 million dollars) have been spent to refit this section of the railroad, but the problem of stabilization remains unsolved. Train speeds are still limited to 15 to 40 km/h, since the threat of unacceptable deformation of the track on this side hill-slope remains. Since this segment of the BAM is electrified, it is critical that the electric contact net and supporting power line towers be repaired as well.

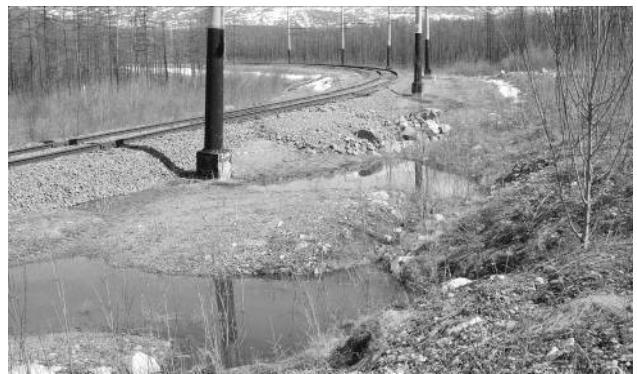
Figure 3. Thaw settlement of embankment of the Chara-Cheena Railroad, May, 2010

To the north of the Transbaikalia, the Chara-Cheena railway line was constructed in 2001. The route extends over an area having extremely complex engineering-geocryological conditions involving ice rich permafrost. In some areas, the underground ice has a thickness of 5 to 10 m. An example of this railway track deformation is shown in Fig. 3.

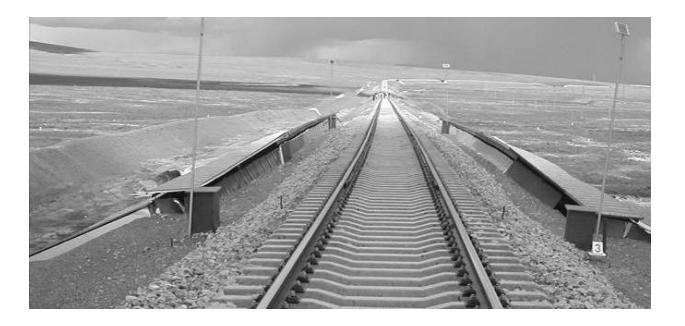
Figure 4. Sun-precipitation protective sheds on the Qinghai-Tibet Railway, August 2006

These technical solutions have been presented in articles, reports and monographs, both in domestic and foreign publications (Kondratiev 1994, 1996, 1998, 2002, 2004, 2006 and 2008). The solutions have been applied on experimental projects while constructing; 1) the Amur-Yakutia trunk line, 2) the connecting Ulak-Elga railway line, and 3) a feasibility study of stabilization measures for use on the Transbaikalian Railroad. Some of these solutions have also been applied on the Qinghai-Tibet Railway in China. An example of the sun-precipitation protective shed, applied to side slopes, is shown in Fig. 4.

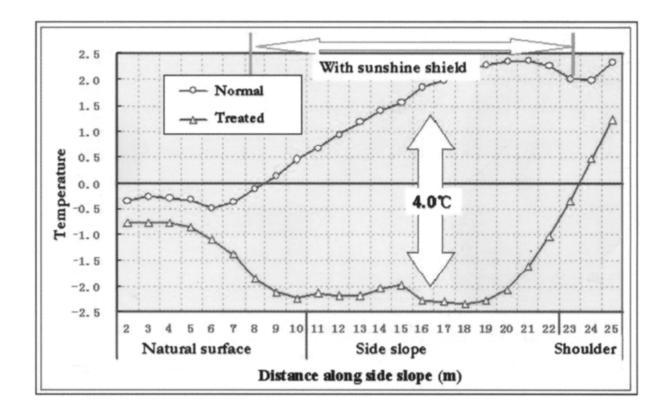
Figure 5. Cooling influence of the sun-precipitation protective sheds, constructed on the embankment slopes of the Qinghai-Tibet Railway (by Niu & Shen 2006).

Data from observations at the full-scale site indicates temperature reductions ranging from 3 to 5° C in the subgrade soil (Fig. 5). This cooling influence serves to improve the stability of the subgrade soil on the highly ice rich permafrost soil (Niu & Shen 2006; Feng Wenjie, Ma Wei, 2006; Feng Wenjie et all 2009).

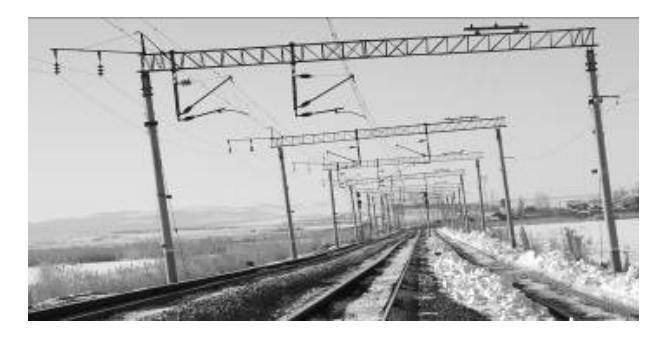
Figure 6. Adverse deformation of power line tower supports along the electrified section of the Transbaikalian Railway, March, 2010

The provision and effective utilization of basic facilities of railways in areas of a permafrost and deep seasonal soil freezing is associated with significant difficulties. As an example, on the Transbaikalian Railroad during the past 10 years (1997 to 2006) at least 17,192 power line tower supports required corrective repairs and 3,294 were replaced. In most cases deformation of support structures were caused by frost jacking within wet friable sediments of seasonally thawed (STL) or seasonally frozen (SFL) layers. Fig. 6 provides an example of the extent of tower deformation.

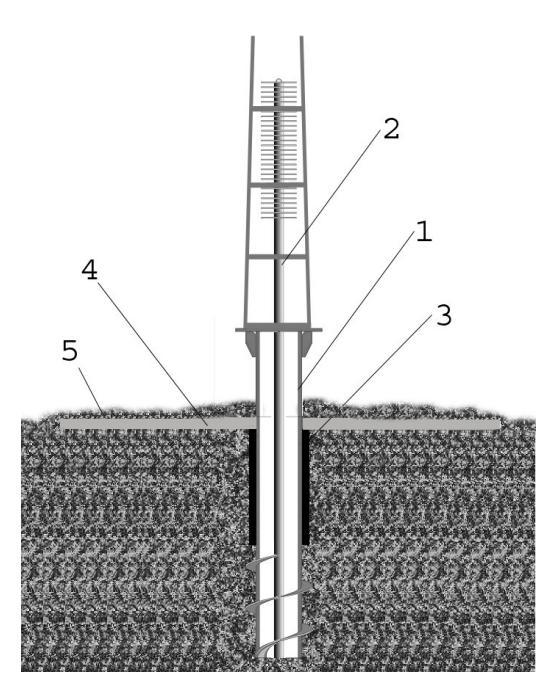
Figure 7. Metal support with screw base (1) with thermosyphon inset (2), anti-frost heaving sleeve (3), thermal insulation (4),covering soil layer (5)

The anti-frost heaving device design for a metal tower support having a screw base (as shown in Fig. 7) consists of three basic elements: the thermosyphon, the thermal insulation and the anti-frost heave sleeve. In October, 2003, anti-frost heaving devices consisting of the thermosyphon structure and a 1.25 m long anti-frost heaving sleeve were installed on five tower support pile bases along the Erofey-Pavlovich-Sgibievo segment of the Transbaikalian Railroad.

Work on placing the insulation layer around the support bases and protective soil cover was performed in April, 2004 after allowing maximum winter freezeback of the soil around the metal support bases. The elevated portion of the supports was then painted with a white cover.

Analysis of the data recovered since November, 2004 shows, owing to the cooling influence of the thermosyphons, that soil freezing near the base (at 0.1 to 0.2 m from the surface) occurred more quickly than at 0.55 to 0.65 m. Around one support, the frozen soil mass that normally by late autumn thaws to a depth of 2.5 to 4 m, was found to preserve the soil in a constantly frozen state around the lower portion of the support at a depth of 1.5 to 3 m.

Periodic level surveys were conducted on the top part of the tower supports and have shown that the tower bases having anti-frost heaving devices have remained stable under the varying conditions of soil freezing and thawing cycles. Measurements indicate the vertical movement does not exceed 10 mm, based on a measurement accuracy of a Class III level survey. Whereas, 20 to 30% of the tower bases not having antifrost heaving devices have begun to heave after 2 to 3 years following installation. Their vertical moving for five annual cycles of freezing-thawing has ranged from 10 to 280 mm.

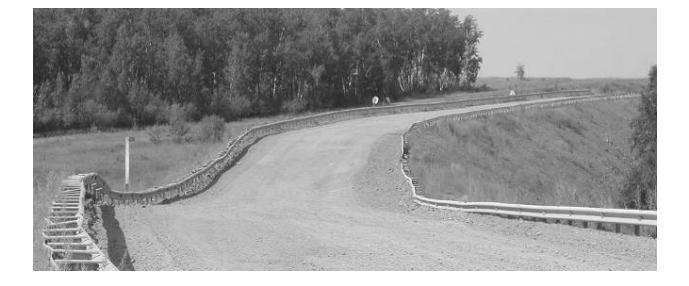
Figure 8. A section of road on the "Amur" Chita to Khabarovsk Highway, km 247, before repairs, July, 2006

This highway is one of the largest contemporary construction efforts in Russia. Construction of the road, having a length of 2,165 km began in 1978 and is planned for completion in 2010. However, even now many sections of the road are subject to constant repairs that are not always successful. As an example, the high embankment on the "Amur" Highway where it passes over Chichon Stream at 247 km is presented. Here the uneven subsidence of the 20 m high embankment has been observed since May, 2001, soon after the delivery of this highway section. Since that time, as evident in Fig. 8, subsidence of the road surface in some places has approached about 2 m, in spite of the periodic addition of soil and the releveling to profile grade.

Both transverse and diagonal cracks, having widths of up to 15 to 20 cm, are opening within the roadway, shoulders and embankment slopes. The pavement surface is also highly deformed. This highway section is in a very distressed condition. The traffic speed for vehicles is now limited to 40 km/h for this section while the designated design speed is 100 km/h.

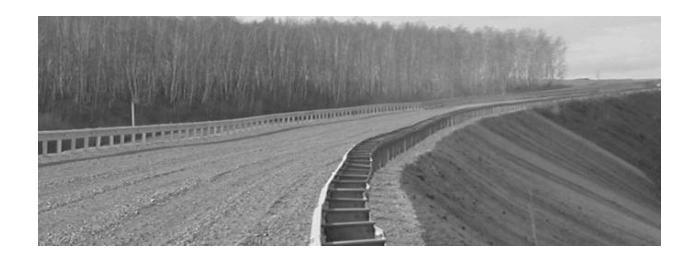
Figure 9. Same section of road on the "Amur" Chita to Khabarovsk highway, km 247, one month after completing innovative repairs, October, 2006

During September, 2006 the innovation repairs of this 200 m failing section, as shown in Fig. 9, was completed.

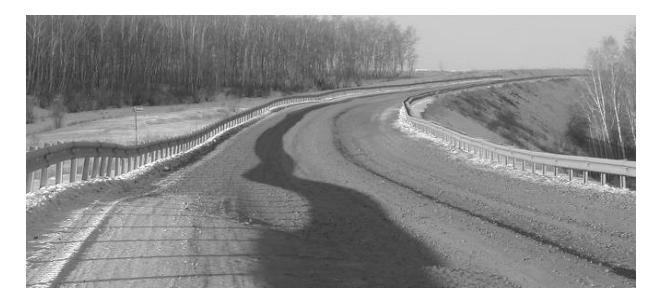
Figure 10. Same section of road on the "Amur" Chita to Khabarovsk, km 247, eighteen months after completing innovative repairs, March, 2008

Almost 10 million rubles have been spent on repairs to date, however, as shown in Fig. 10, deformation of the embankment section continues. The subgrade soil in this section consists of 15 to 20 m of permafrost with the larger part being ice rich soil, that settle and flow upon thawing. As a result, permafrost degradation and corresponding deformation of the road under the prevailing conditions is expected to continue indefinitely.

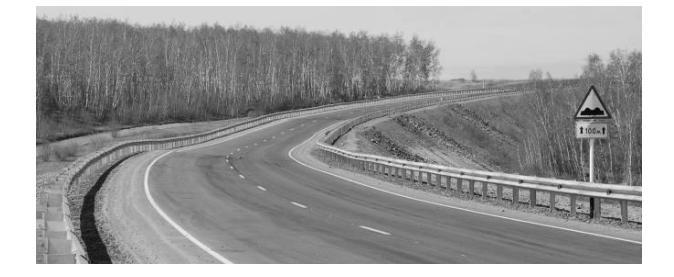
Figure 11. Same section of road on the "Amur" Chita to Khabarovsk, km 247, eight months after completing last repair and asphalting, May, 2010

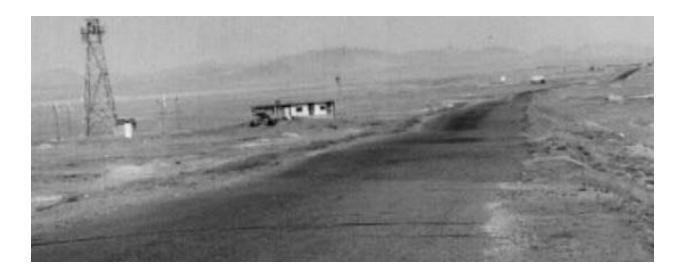
Figure 12. The Qinghai-Tibet Highway, October, 2002

In the 1950's the Qinghai-Tibet Highway was constructed with a gravel-crushed stone coating. In the 1980's, it was reconstructed, and in may sections, asphalt pavement was applied. This black pavement surface accelerated degradation of permafrost within the subgrade, producing significant surface deformations in those sections having ice rich soils (Fig. 12).

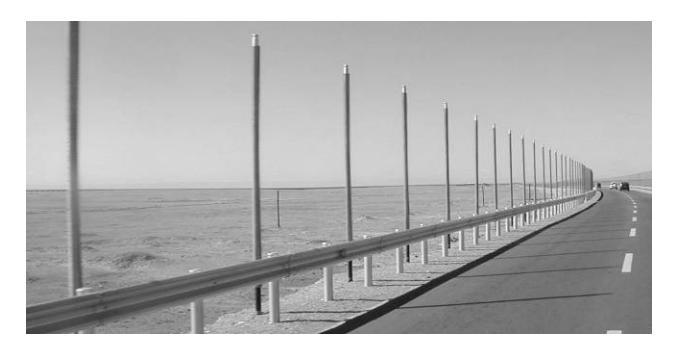
Figure 13. One line of thermosyphons along the Qinghai-Tibet Highway, September, 2004

Recently, the highway was reconstructed to meet contemporary high speed vehicle standards. The highway, in essence, traverses parallel with the Qinghai-Tibet Railway. The highway has a hard-surfaced pavement and utilizes anti-frost heaving measures in the sections having ice rich soils. At some of these locations, thermosyphons have been placed in the form of one (Fig. 13) or two (Fig. 14) lines along roadway shoulders,

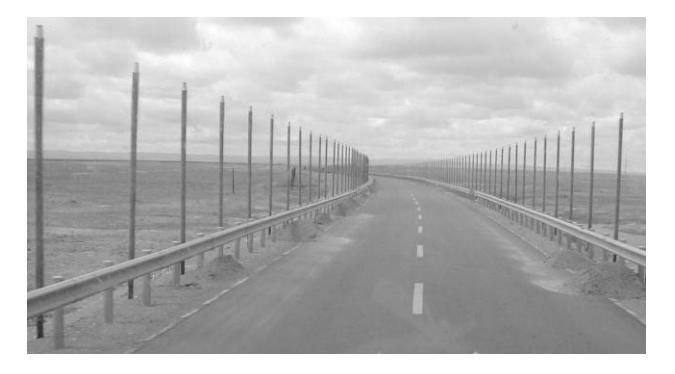
Figure 14. Two line of thermosyphons along the Qinghai-Tibet Highway, August, 2006

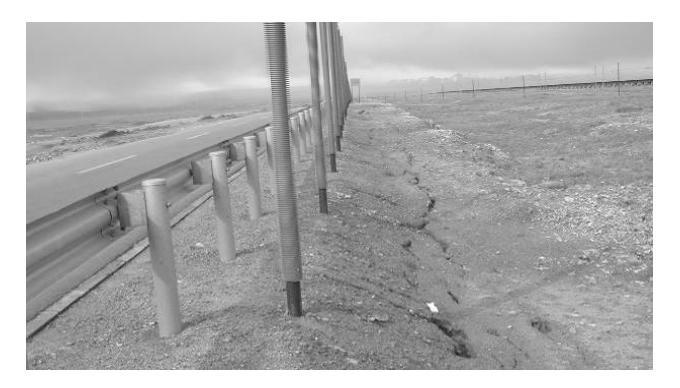
Figure 15. Deformation and displacement of an embankment slope on the Qinghai-Tibet Highway as a

result of permafrost degradation outside the influence area of the thermosyphons, August, 2006

However, as can be seen in Fig. 15, some embankment problems have begun to occur. It is also expected that the thermosyphons will not protect the road from the thermokarsts, because of their limited radius of cooling.
