## Groundwater Metals Contamination and Construction Dewatering: Challenges and Effective Solutions

Christina Trotter, Cory Nelson

*PGL Environmental Consultants, Vancouver, British Columbia, Canada*

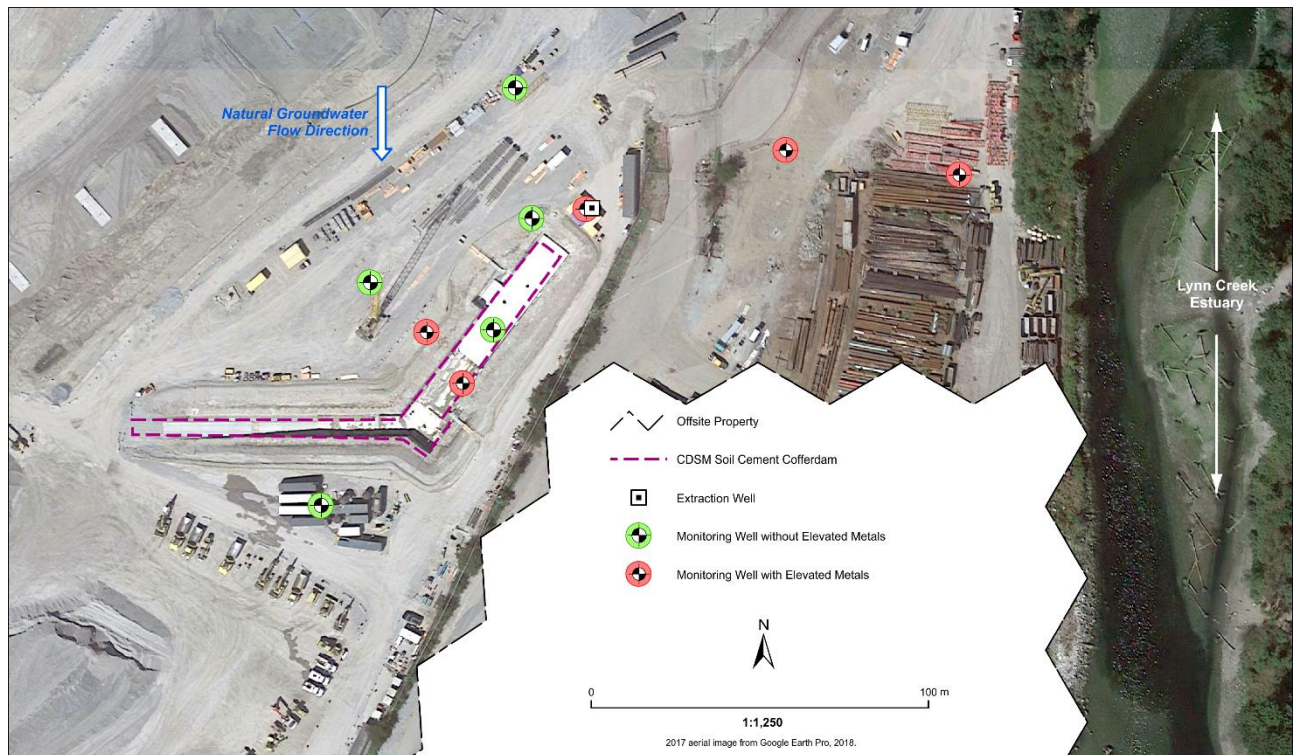
**Figure 1: Site plan with key features. Scale and locations are approximate.**

The extraction well was placed at north edge of the proposed excavation where the worst-case metals contamination on the Site was measured but where non-contaminated groundwater was also documented to the west and south (Figure 1). As the pumping rate was low, the pumping duration had to be as long as possible to maximize the capture zone. A 96-hour pumping test was completed. Concentrations of metals in groundwater and water levels in monitoring wells were measured frequently. A tracer was deployed in a cross-gradient monitoring well to improve characterization of the capture zone given the noise created by large tidal fluctuations.
